Department of Transportation
Federal Highway
Administration

The following device is eligible within the length-of-need, with details provided in the form which is attached as an integral part of this letter:

- Big Sandy MASH

Name of system: Big Sandy MASH
Type of system: Crash Cushion
Test Level: MASH Test Level 3 (TL3)
Testing conducted by: KARCO
Date of request: September 14, 2017
Date initially acknowledged: September 20, 2017

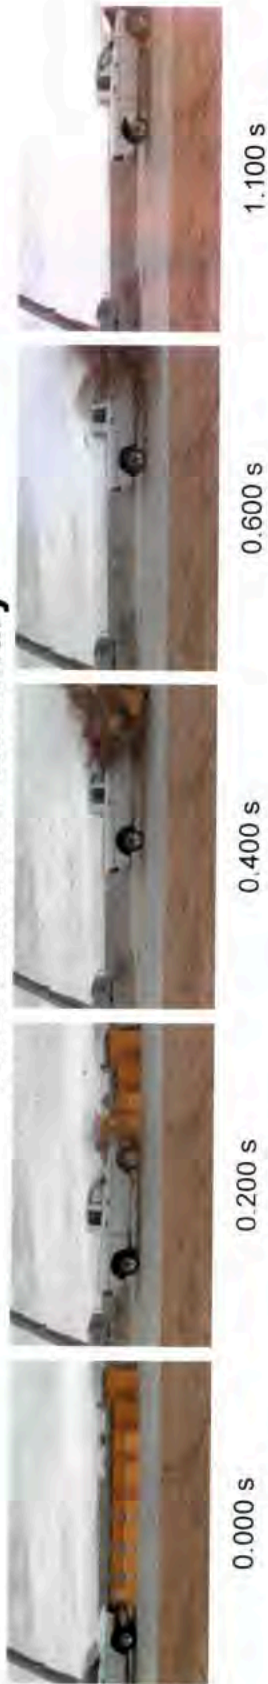
Figure 2 Summary of Test 3-41

MASH Test 3-41 Summary

General Information	
Test Agency	KARCO Engineering, LLC
KARCO Test No.	P37007-01
Test Designation	3-41
Test Date	2/27/17
Test Article	
Name / Model	Big Sandy
Type	Crash Cushion
Article Length	28.1 ft (8.6 m)
Installation Length	49.1 ft (15.0 m)
Road Surface	Cement
Test Vehicle	
Type / Designation	2270P
Year, Make, and Model	2012 RAM 1500
Curb Mass	5,028.7 lbs (2,281.0 kg)
Test Inertial Mass	5,015.4 lbs (2,275.0 kg)
Gross Static Mass	5,015.4 lbs (2,275.0 kg)

Impact Conditions	
Impact Velocity	62.96 mph (101.32 km/h)
Impact Angle	0.1°
Location / Orientation	0.5 in (13 mm) right of the article's centerline
Kinetic Energy	664.8 kip-ft (901.3 kJ)
Exit Conditions	
Exit Velocity	N/A
Exit Angle	N/A
Final Vehicle Position	28.1 ft (8.6 m) downstream 10.3 in. (261 mm) left
Vehicle Snagging	None
Vehicle Pockeling	None
Vehicle Stability	Satisfactory
Maximum Roll Angle	4.7°
Maximum Pitch Angle	6.7°
Maximum Yaw Angle	-4.5°

Occupant Risk	
Longitudinal OIV	26.9 ft/s (8.2 m/s)
Lateral OIV	4.6 ft/s (1.4 m/s)
Longitudinal RA	-12.4 g
Lateral RA	2.2 g
THIV	27.2 ft/s (8.3 m/s)
PHD	12.5 g
ASI	0.82
Test Article Deflections	
Static	N/A
Maximum Debris Field	65.5 ft. (20.0 m) left 101.9 ft. (31.0 m) forward
Vehicle Damage	
Vehicle Damage Scale	12-FC-4
CDC	12FDEW3
Maximum Intrusion	Floorpan

3-41 (2270P)	<p>The Big Sandy Array was positioned inline with the center of the test vehicle. The inline centered position examines the risk of exceeding occupant risk values, vehicle instability, the system's capacity to absorb sufficient impact energy and the Big Sandy's ability to bring the vehicle to a safe controlled stop. The test was conducted using a commercially available 2012 Dodge Ram 4-door pickup truck with a test inertial mass of 5015.4 lbs (2275.0 kg). The vehicle was in good condition, was free of major body damage, and was not missing any structural components. The bumpers were standard equipment and were not modified for this test. Based on CarFax reporting there was no recorded history of major accidents, was not a salvage titled vehicle, not involved in flooding, or fire.</p> <p>The test vehicle impacted the front 200 lbs (90 kg) combo barrel in the array at a velocity of 62.96 mph (101.32 km/hr) and at an impact angle of 0.1° resulting in the barrel fracturing into pieces and dispersing the contained sand. As the test vehicle intruded further into the array the sand barrels that came into contact with the vehicle fractured into pieces and dispersed the contained sand. The vehicle came to a controlled stop 28.1 ft (8.6 m) forward and 10.3 in (261 mm) to the left of the initial impact. The vehicle remained upright throughout the impact event. The test vehicle's occupant compartment was not penetrated and there was no measurable in cab deformation beyond the allowed limit defined in MASH. The maximum roll and pitch angle did not exceed 75° and occupant risk values are within limits per MASH specifications for Occupant Impact Velocity and Ridedown Acceleration.</p>	PASS

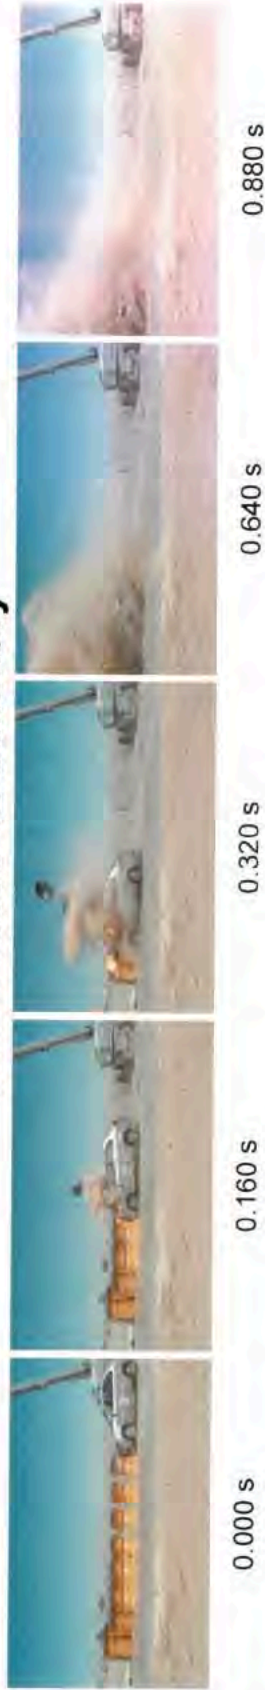
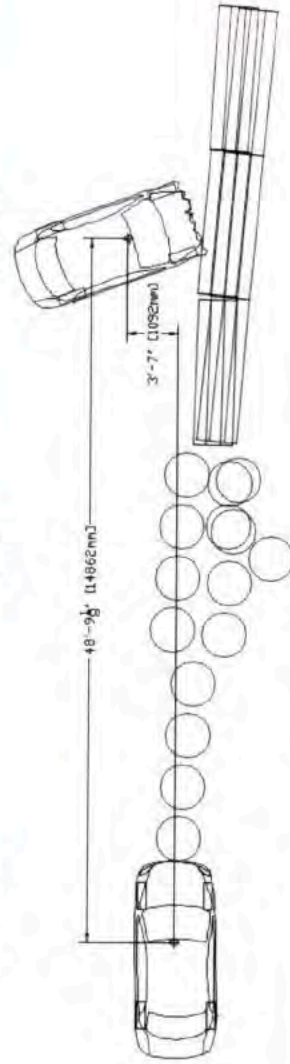
Figure 2 Summary of Test 3-42

MASH Test 3-42 Summary

<u>General Information</u>	
Test Agency	KARCO Engineering, LLC.
KARCO Test No.	P37115-01
Test Designation	3-42
Test Date	4/14/17
<u>Test Article</u>	
Name / Model	Big Sandy
Type	Crash Cushion
Article Length	28.1 ft (8.6 m)
Installation Length	59.1 ft (18.0 m)
Road Surface	Concrete
<u>Test Vehicle</u>	
Type / Designation	1100C
Year, Make, and Model	2011 Kia Rio
Curb Mass	2,307.1 lbs (1,046.5 kg)
Test Inertial Mass	2,401.9 lbs (1,089.5 kg)
Gross Static Mass	2,572.8 lbs (1,167.0 kg)

<u>Impact Conditions</u>	
Impact Velocity	66.58 mph (107.15 km/h)
Impact Angle	5.2°
Location / Orientation	1.0 in (25 mm) right of the vehicles centerline
Kinetic Energy	355.9 kip-ft (482.6 kJ)
<u>Exit Conditions</u>	
Exit Velocity	N/A
Exit Angle	N/A
Final Vehicle Position	48.8 ft (14.9 m) downstream 3.6 ft (1.1 m) left
Vehicle Snagging	None
Vehicle Pocketing	None
Vehicle Stability	Satisfactory
Maximum Roll Angle	5.0°
Maximum Pitch Angle	-3.2°
Maximum Yaw Angle	28.8°

<u>Occupant Risk</u>	
Longitudinal OIV	23.6 ft/s (7.2 m/s)
Lateral OIV	2.0 ft/s (0.6 m/s)
Longitudinal RA	-14.5 g
Lateral RA	2.8 g
THIV	23.6 ft/s (7.2 m/s)
PHD	14.5
ASI	0.8
<u>Test Article Deflections</u>	
Static	N/A
Maximum Debris Field	54.6 ft. (16.6 m) left 105.3 ft. (32.1 m) forward
<u>Vehicle Damage</u>	
Vehicle Damage Scale	12-FC-3
CDC	12FDEW2
Maximum Intrusion	Windshield

3-42 (1100C)	<p>The Big Sandy Array was positioned at a nominal angle of 5° with the center of the test vehicle. The angle position examines the risk of exceeding occupant risk values, vehicle instability, capacity to absorb sufficient impact energy, and the Big Sandy's ability to bring the vehicle to a safe controlled stop. The test was conducted using a commercially available 2011 Kia Rio 4-door sedan with a test inertial mass of 2401.9 lbs (1089.5 kg). The vehicle was in good condition, was free of major body damage, and was not missing any structural components. The bumpers were standard equipment and were not modified for this test. Based on CarFax reporting there was no recorded history of major accidents, was not a salvage titled vehicle, not involved in flooding, or fire. The test vehicle impacted the front 200 lb (90 kg) combo barrel in the array at a velocity of 66.58 mph (107.15 km/hr) and at an impact angle of 5.2° resulting in the barrel fracturing into pieces and dispersing the contained sand. As the test vehicle intruded further into the array the sand barrels that came into contact with the vehicle fractured into pieces and dispersed the contained sand. The vehicle rotated about its yaw axis before coming to a controlled stop 48.8 ft (14.9 m) forward and 3.6 ft (1.1 m) to the left of the initial impact. The vehicle remained upright throughout the impact event. The test vehicle's occupant compartment was not penetrated and measurable in cab deformation was deemed acceptable. The maximum roll and pitch angle did not exceed 75°. Occupant risk values are within limits per MASH specifications for Occupant Impact Velocity and Ridedown Acceleration.</p>	PASS

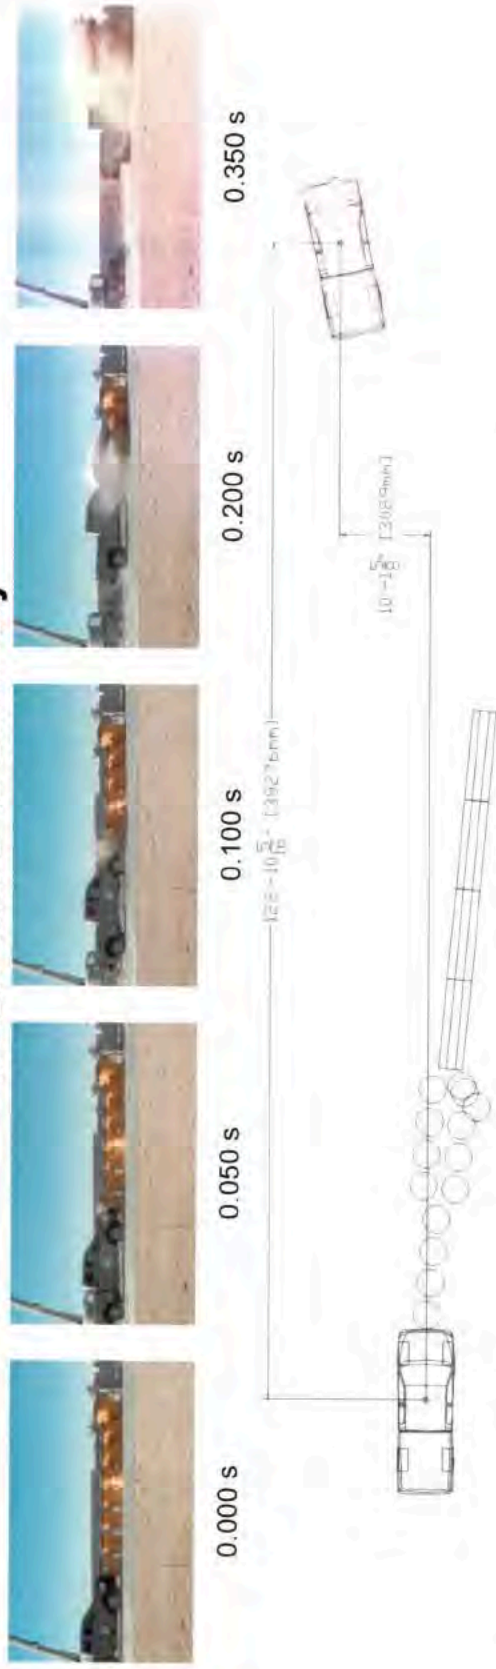
Figure 2 Summary of Test 3-43

MASH Test 3-43 Summary

<u>General Information</u>	
Test Agency	KARCO Engineering, LLC
KARCO Test No.	P37168-01
Test Designation	3-43
Test Date	05/18/17
<u>Test Article</u>	
Name / Model	Big Sandy
Type	Crash Cushion
Article Length	28.1 ft. (8.6 m)
Installation Length	49.1 ft (15.0 m)
Road Surface	Concrete
<u>Test Vehicle</u>	
Type / Designation	2270P
Year, Make, and Model	2012 Ram 1500
Curb Mass	5,007.7 lbs (2,271.5 kg)
Test Inertial Mass	4,968.0 lbs (2,253.5 kg)
Gross Static Mass	4,968.0 lbs (2,253.5 kg)

<u>Impact Conditions</u>	
Impact Velocity	62.09 mph (99.92 km/h)
Impact Angle	5.6°
Location / Orientation	0.8 in (21 mm) left of the article's centerline
Kinetic Energy	640.3 kip-ft (868.1 kJ)
<u>Exit Conditions</u>	
Exit Velocity	N/A
Exit Angle	N/A
Final Vehicle Position	128.9 ft (39.3 m) downstream 10.1 ft. (3.1 m) left
Vehicle Snagging	None
Vehicle Pocketing	None
Vehicle Stability	Satisfactory
Maximum Roll Angle	5.5°
Maximum Pitch Angle	3.7°
Maximum Yaw Angle	-7.8°

<u>Occupant Risk</u>	
Longitudinal OIV	23.6 ft/s (7.2 m/s)
Lateral OIV	1.3 ft/s (0.4 m/s)
Longitudinal RA	-9.1 g
Lateral RA	-2.3 g
THIV	23.6 ft/s (7.2 m/s)
PHD	9.4 g
ASI	0.59
<u>Test Article Deflections</u>	
Static	N/A
Maximum Debris Field	65.5 ft. (20.0 m) left 127.6 ft. (38.9 m) forward
<u>Vehicle Damage</u>	
Vehicle Damage Scale	12-FC-4
CDC	12FDEW3
Maximum Intrusion	Floorpan

3-43 (2270P)	<p>The Big Sandy Array was positioned at a nominal angle of 5° with the center of the test vehicle. The angle position examines the risk of exceeding occupant risk values, vehicle instability, capacity to absorb sufficient impact energy, and the Big Sandy's ability to bring the vehicle to a safe controlled stop. The test was conducted using a commercially available 2012 Dodge Ram 4-door pickup truck with a test inertial mass of 4968.0 lbs (2253.5 kg). The vehicle was in good condition, was free of major body damage, and was not missing any structural components. The bumpers were standard equipment and were not modified for this test. Based on CarFax reporting there was no recorded history of major accidents, was not a salvage titled vehicle, not involved in flooding, or fire. The test vehicle impacted the front 200 lb (90 kg) combo barrel in the array at a velocity of 62.09 mph (99.92 km/hr) and at an impact angle of 5.6 ° resulting in the barrel fracturing into pieces and dispersing the contained sand. As the test vehicle intruded further into the array the sand barrels that came into contact with the vehicle fractured into pieces and dispersed the contained sand. The vehicle rotated about its yaw axis before coming to a controlled stop 128.9 ft (39.3 m) forward and 10.1 ft (3.1 m) to the left of the initial impact. The vehicle remained upright throughout the impact event. The test vehicle's occupant compartment was not penetrated and there were no measurable in cab deformation beyond the allowed limit defined in MASH. The maximum roll and pitch angle did not exceed 75°. Occupant risk values are within limits per MASH specifications for Occupant Impact Velocity and Ridedown Acceleration.</p>	PASS

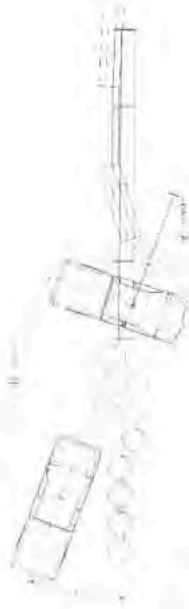
Figure 2 Summary of Test 3-44

MASH Test 3-44 Summary

Test Agency..... KARCO Engineering, LLC.
 KARCO Test No..... P36301-01
 Test Designation..... 3-44
 Test Date..... 03/02/17

Name / Model..... Big Sandy
 Type..... Crash Cushion
 Article Length..... 28.1 ft (8.6 m)
 Installation Length..... 49.1 ft (15.0 m)
 Road Surface..... Concrete

Impact Velocity..... 60.32 mph (97.07 km/h)
 Impact Angle..... 20.2°
 Location / Orientation..... 0.6 in (15 mm) right of the
 intended impact point
 Kinetic Energy..... 608.7 kip-ft (825.3 kJ)

Longitudinal OIV..... 31.2 ft/s (9.5 m/s)
 Lateral OIV..... 3.6 ft/s (1.1 m/s)
 Longitudinal RA..... -24.4 g
 Lateral RA..... 5.2 g
 THIV..... 31.5 ft/s (9.6 m/s)
 PHD..... 24.4 g
 ASI..... 1.34

Vehicle Damage Scale..... 12-FC-5
 CDC..... 12FDEW3
 Maximum Intrusion..... Floorpan

3-44 (2270P)	<p>The Big Sandy Array was positioned at a nominal angle of 20° and the center line of the impacting vehicle was directed at the corner of the barrier. The vehicle impacted the crash cushion 14.63 ft (4.4 m) from the barrier and 2.44 ft (0.743 m) from the center line of the vehicle. Two 3-44 tests were run. One conducted with freestanding barrier and one with permanently anchored barrier</p> <p>For the test with freestanding barrier (Report TR-P36301) a 2012 Ram 4-door truck was used with an inertial mass of 5004.4 lbs (2270.0 kg), at an impact velocity of 60.32 mph (97.07 km/hr), and at an impact angle of 20.2 °. The vehicle rotated in a clockwise direction about the vertical axis and came to a controlled stop 26.7 ft (8.1 m) forward and 2.4 in (61 mm) from the impact point.</p> <p>For the test with anchored barrier (Report TR-38019) a 2013 Ram 4-door truck was used with an inertial mass of 4995.6 lbs (2266.0 kg), at an impact velocity of 61.26 mph (98.59 km/hr), and at an impact angle of 19.9 °. The vehicle rotated in a clockwise direction about the vertical axis and came to a controlled stop 18.2 ft (5.6 m) forward and 6.2 ft (1.9 m) from the impact point.</p> <p>For both 3-44 tests the truck contacted the first double row of 700 lbs (320 kg) barrels approx. 13.5 ft (4.1 m) from the front of the Big Sandy System. The first impacted barrels fractured dispersing the contained sand. As the vehicle intruded further into the array all the barrels rearward fractured and dispersed the contained sand.</p> <p>The CIP was defined in specifications in MASH for test procedures for Gating Non-Redirective Crash Cushions. The trucks were free of major body damage and based on CarFax there was no recorded history of major accidents. For both tests the truck remained upright, and did not exhibit vaulting. The maximum roll and pitch angle did not exceed 75°. The occupant compartments were not penetrated and there were no measurable in cab deformation beyond the allowed limit defined in MASH.</p>	PASS

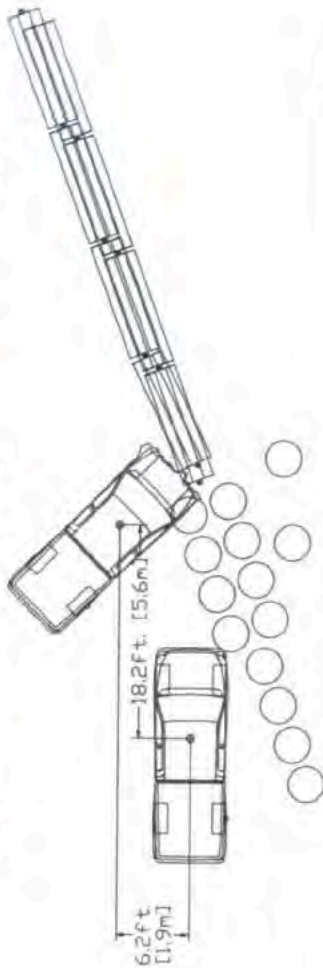
Figure 2 Summary of Test 3-44

MASH Test 3-44 Summary

Test Agency..... KARCO Engineering, LLC
 KARCO Test No..... P38019-01
 Test Designation..... 3-44
 Test Date..... 01/05/18

Name / Model..... Big Sandy
 Type..... Crash Cushion
 Article Length..... 28.1 ft (8.6 m)
 Installation Length..... 49.1 ft (15.0 m)
 Road Surface..... Concrete

Impact Velocity..... 61.26 mph (98.59 km/h)
 Impact Angle..... 19.9°
 Location / Orientation..... Center of vehicle to corner of backup structure
 Kinetic Energy..... 626.7 kip-ft (849.7 kJ)

Longitudinal OIV..... 35.8 ft/s (10.9 m/s)
 Lateral OIV..... 4.3 ft/s (1.3 m/s)
 Longitudinal RA..... -23.3 g
 Lateral RA..... 4.0 g
 THIV..... 35.8 ft/s (10.9 m/s)
 PHD..... 23.3 g
 ASI..... 1.45

Vehicle Damage Scale..... 12-FC-5
 CDC..... 12FDEW3
 Maximum Intrusion..... Floorpan

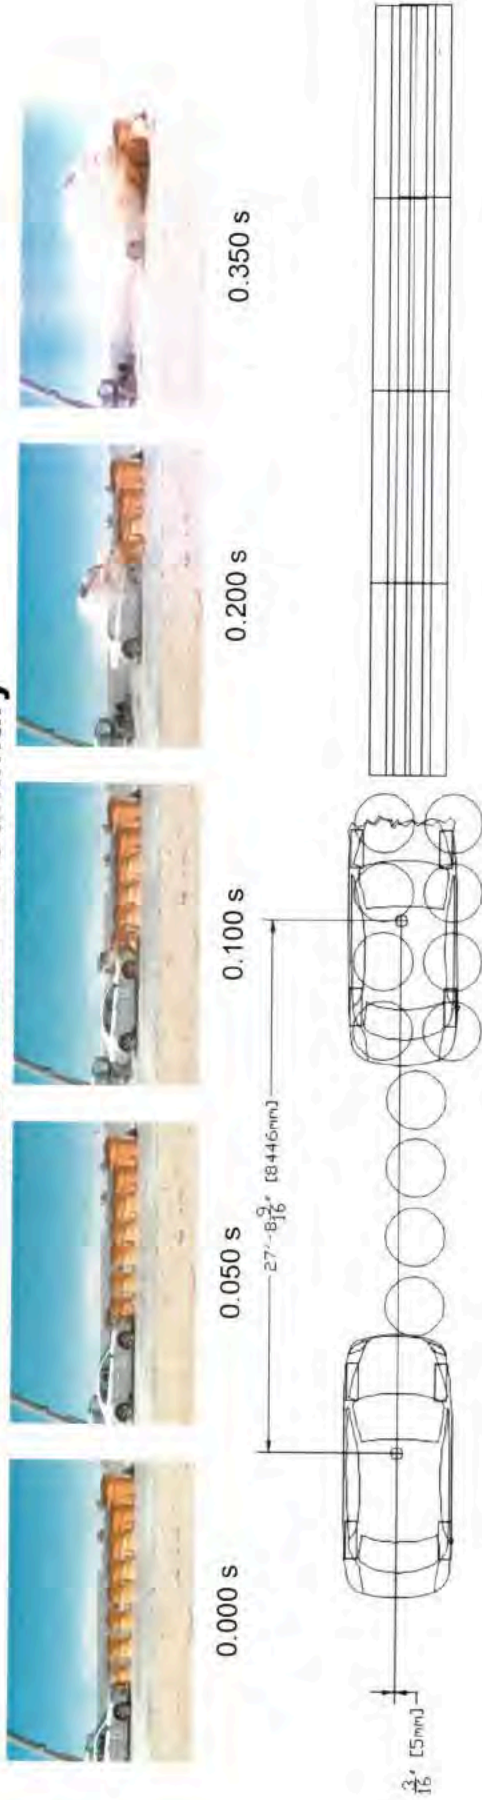
Figure 2 Summary of Test 3-45

MASH Test 3-45 Summary

General Information	
Test Agency	KARCO Engineering, LLC
KARCO Test No.	P37167-01
Test Designation	3-45
Test Date	5/16/17
Test Article	
Name / Model	Big Sandy
Type	Crash Cushion
Article Length	28.1 ft. (8.6 m)
Installation Length	49.1 ft. (15.0 m)
Road Surface	Concrete
Test Vehicle	
Type / Designation	1500A
Year, Make, and Model	2012 Chevrolet Malibu
Curb Mass	3,263.9 lbs (1,480.5 kg)
Test Inertial Mass	3,284.8 lbs (1,490.0 kg)
Gross Static Mass	3,284.8 lbs (1,490.0 kg)

Impact Conditions	
Impact Velocity	61.31 mph (98.67 km/h)
Impact Angle	0.6°
Location / Orientation	0.6 in (16 mm) left of the article's centerline
Kinetic Energy	412.8 kip-ft (559.6 kJ)
Exit Conditions	
Exit Velocity	N/A
Exit Angle	N/A
Final Vehicle Position	27.7 ft (8.4 m) downstream
Vehicle Snagging	None
Vehicle Pocketing	None
Vehicle Stability	Satisfactory
Maximum Roll Angle	5.6°
Maximum Pitch Angle	2.7°
Maximum Yaw Angle	-4.5°

Occupant Risk	
Longitudinal OIV	22.3 ft/s (6.8 m/s)
Lateral OIV	0.7 ft/s (0.2 m/s)
Longitudinal RA	-13.8 g
Lateral RA	1.2 g
THIV	22.3 ft/s (6.8 m/s)
PHD	13.8 g
ASI	0.79
Test Article Deflections	
Static	N/A
Maximum Debris Field	65.5 ft. (20.0 m) left 92.2 ft. (28.1 m) forward
Vehicle Damage	
Vehicle Damage Scale	12-FC-4
CDC	12FDEW3
Maximum Intrusion	N/A

3-45 (1500A)	<p>The Big Sandy Array was positioned inline the with center of the test vehicle. The inline centered position examines the risk of exceeding occupant risk values, vehicle instability, capacity to absorb sufficient impact energy, and the Big Sandy's ability to bring the vehicle to a safe controlled stop. The test was conducted using a commercially available 2012 Chevy Malibu 4-door sedan with a test inertial mass of 3284.8 lbs (1490.0 kg). The vehicle was in good condition, was free of major body damage, and was not missing any structural components. The bumpers were standard equipment and were not modified for this test. Based on CarFax reporting there was no recorded history of major accidents, was not a salvage titled vehicle, not involved in flooding, or fire. The test vehicle impacted the front 200 lb (90 kg) combo barrel in the array at a velocity of 61.31 mph (98.67 km/hr) and at an impact angle of 0.6° resulting in the barrel fracturing into pieces dispersing the contained sand. As the test vehicle intruded further into the array the sand barrels that came into contact with the vehicle fractured into pieces and dispersed the contained sand. The vehicle came to a controlled stop 27.7 ft (8.4 m) forward from the initial impact. The vehicle remained upright throughout the impact event. The test vehicle's occupant compartment was not penetrated and there was no measurable in cab deformation beyond the allowed limit defined in MASH. The maximum roll and pitch angle did not exceed 75° and occupant risk values are within limits per MASH specifications for Occupant Impact Velocity and Ridedown Acceleration.</p>	PASS

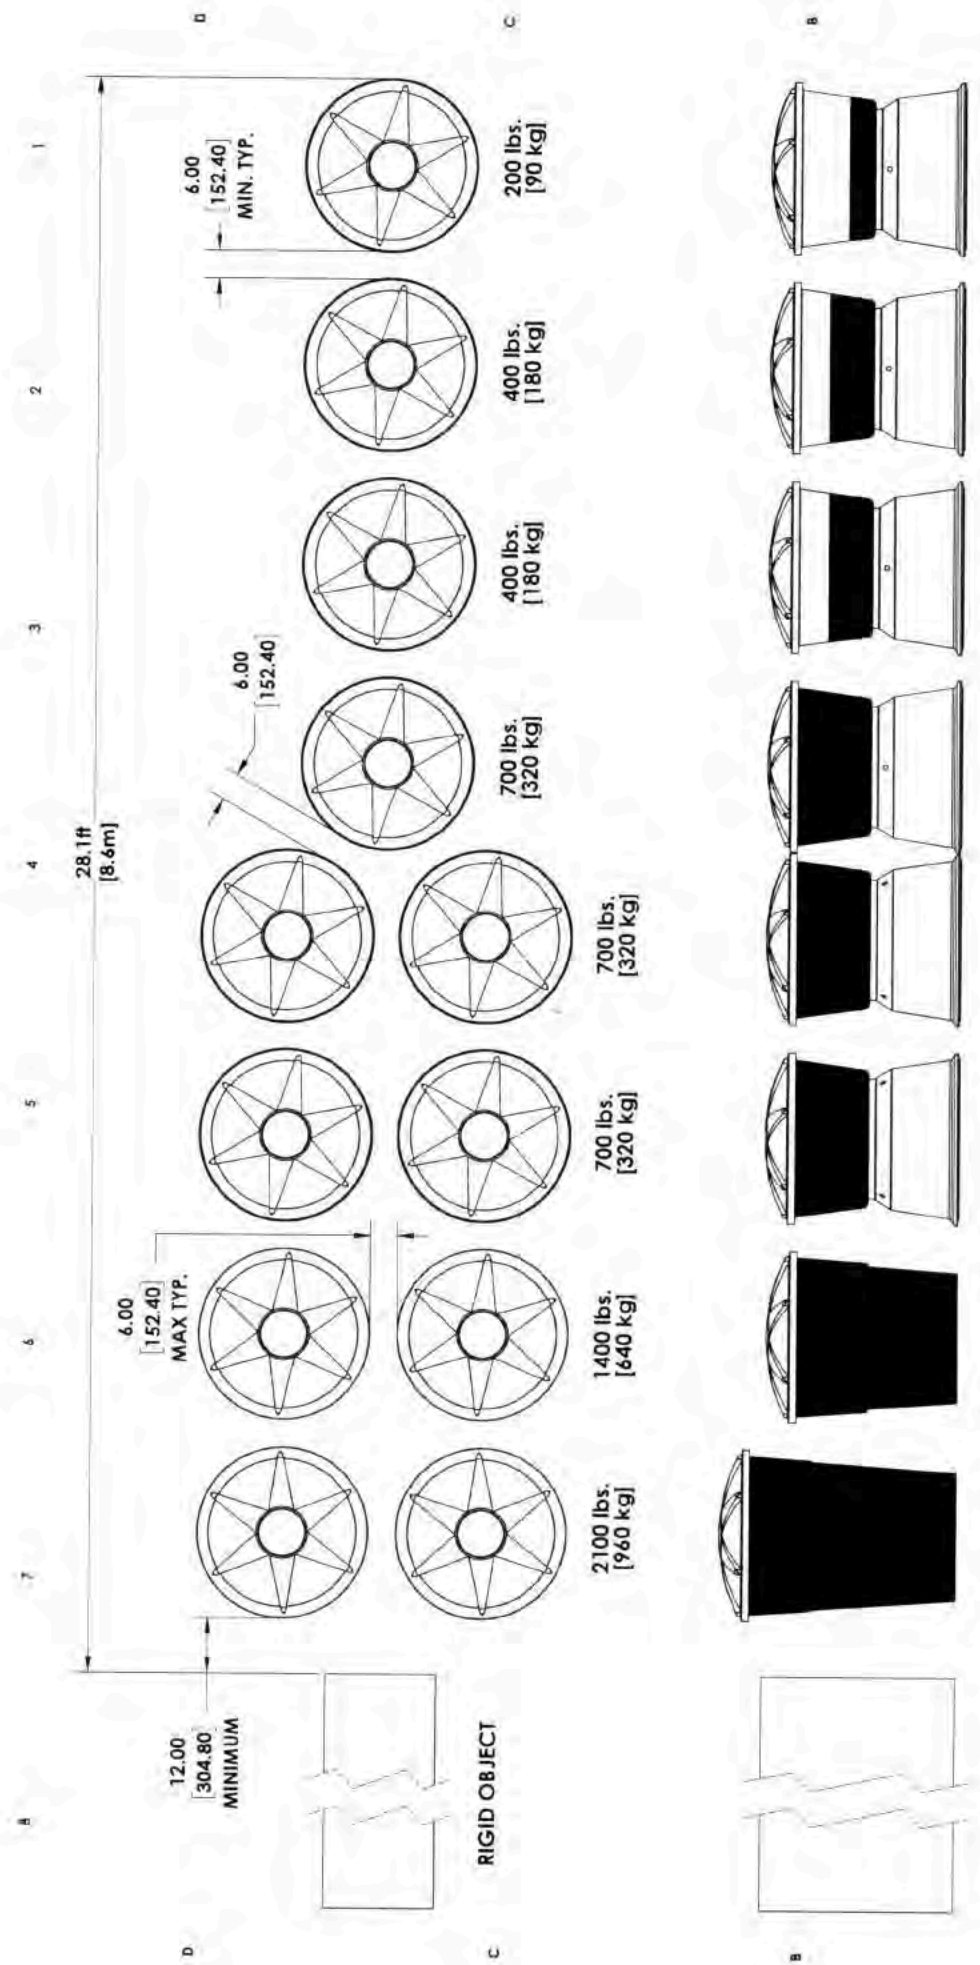
DWG. NO.: **200-100**

**Big Sandy
 12 Barrel Array**

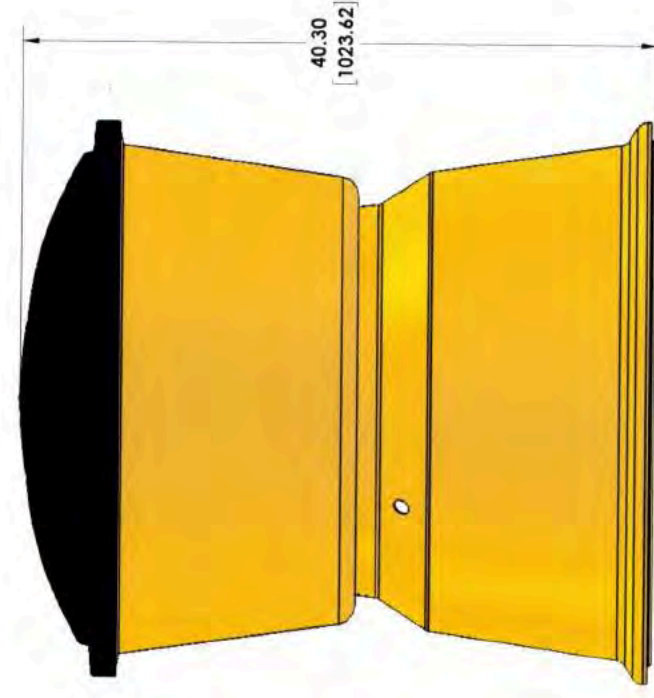
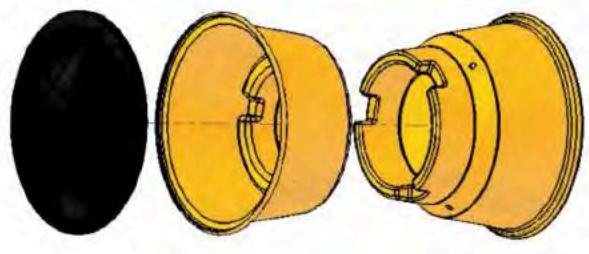
SIZE **B** DWG. NO. **200-101** REV **C**
 SHEET 1 OF 1

Exploded View

Assembled View

Big Sandy Combo Barrel

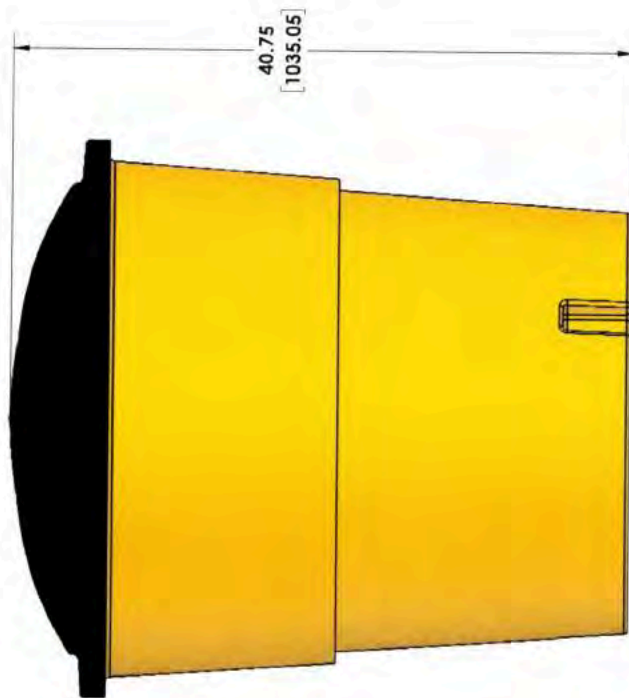
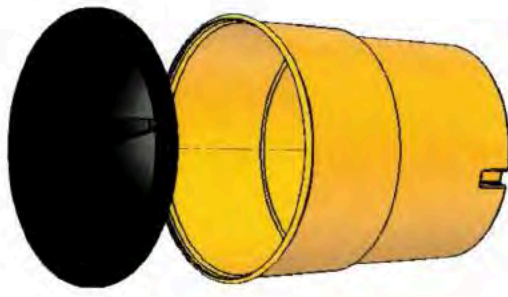
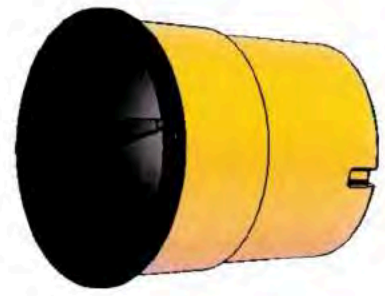
SIZE DWG. NO. REV
B **200-102** **C**

Exploded View

Assembled View

Big Sandy 1400 lbs. Barrel

The Big Sandy barrels come in three configurations 2100 lb. (960 kg) barrels with an overall height of 52.5 in. (1333.5mm), 1400 lb. (640 kg) barrels with an overall height of 40.75 in. (1035mm), and a two-piece combo barrel consisting of a pedestal base, and an upper canister. When assembled, the hour glass shaped combo barrel has a height of 40.3 in. (1024mm). Combo barrels have three molded in marks designating three weight demarcation fill levels. The bottom mark designates a fill level of 200 lbs. (90kg) of sand. The middle mark designates 400 lbs. (180kg) of sand. The top mark designates 700 lbs. (320 kg) of sand. All Big Sandy barrels utilize the same 37 in (940 mm) diameter snap on lid.

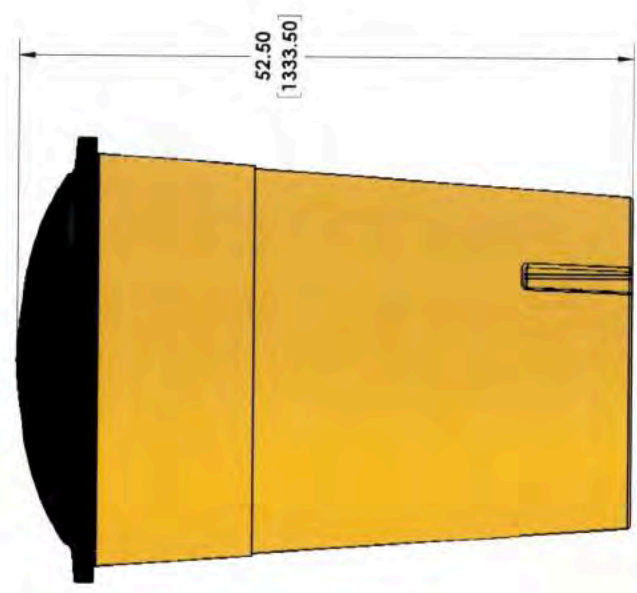
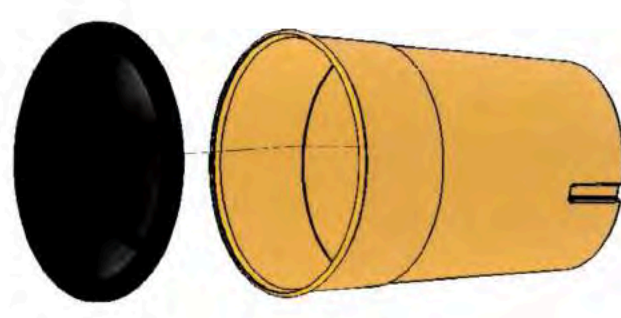
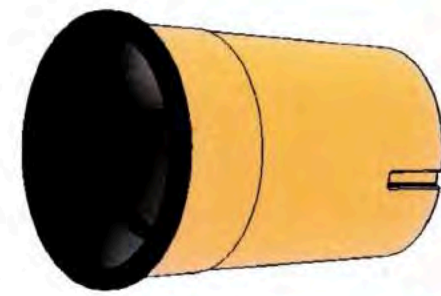
SIZE **B** DWG. NO. **200-103** REV **C**
 SHEET 1 OF 1

Exploded View

Assembled View

Big Sandy 2100 lbs. Barrel

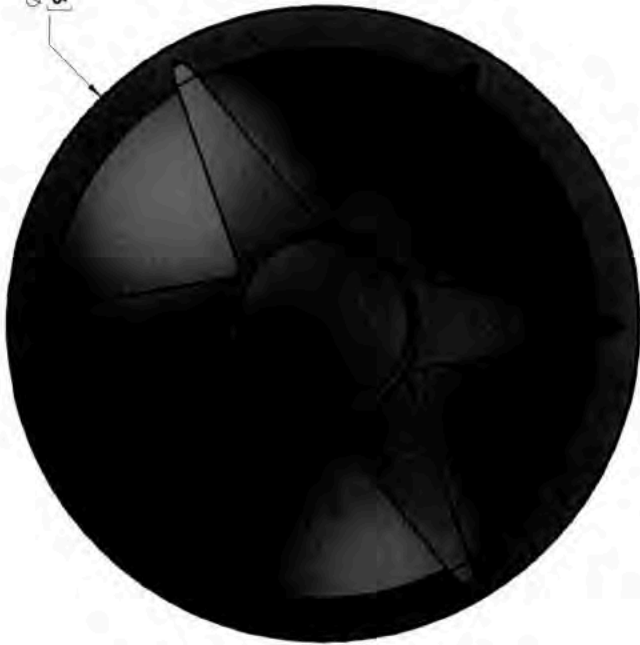
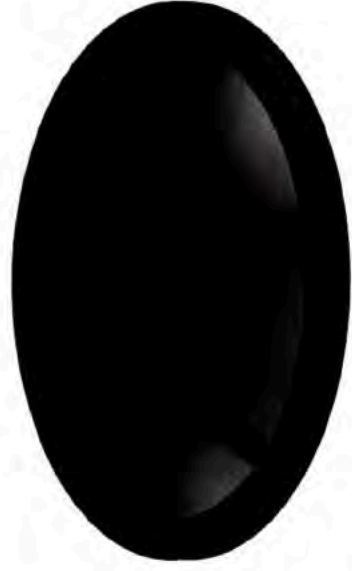
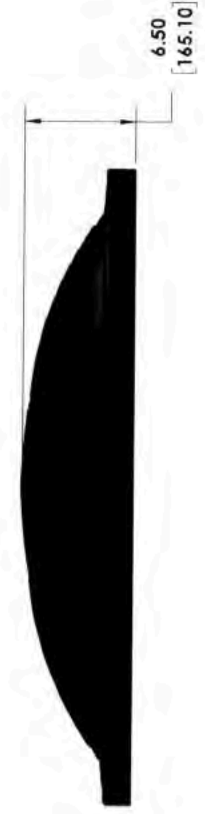
SIZE: **B**
 DWG. NO.: **200-104**
 REV: **A1**
 SHEET 1 OF 1

Big Sandy Lid

2. Material: Black Polyethylene Plastic
 1. Units: inches (mm)
 NOTES: UNLESS OTHERWISE SPECIFIED

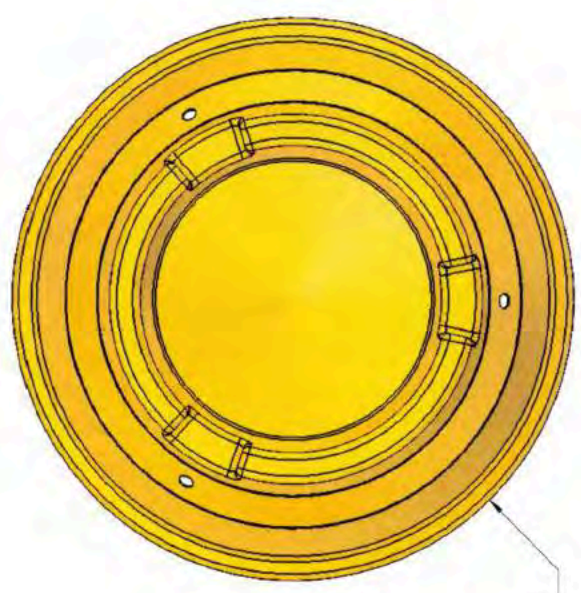
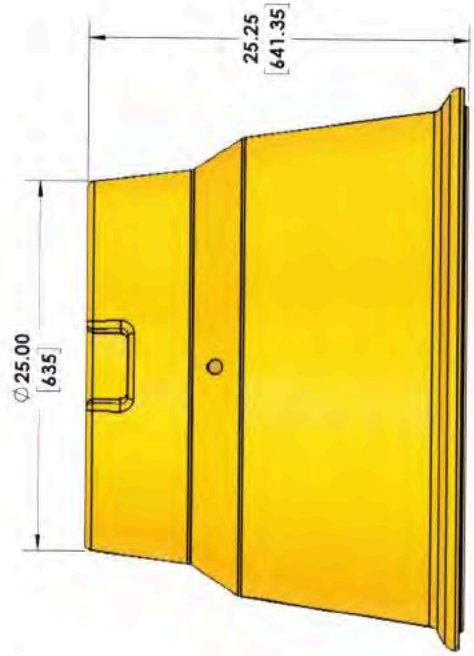
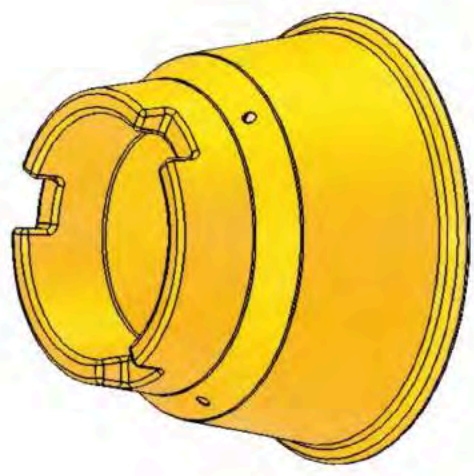
200-105

Ø 37.50
[952.50]

Ø 25.00
[635]

25.25
[641.35]

**Pedestal, Big Sandy
Combo Barrel**

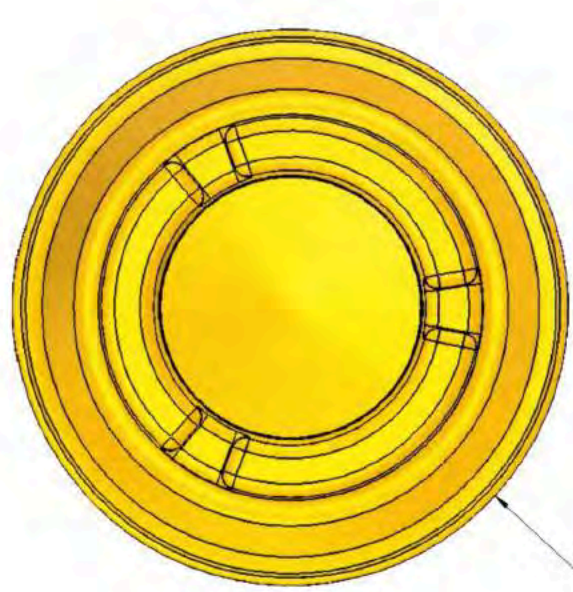
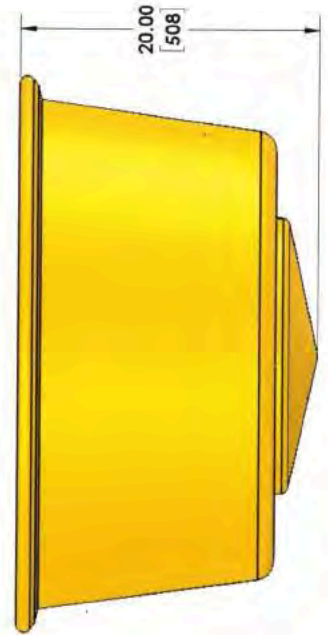
Ø 37.00
[939.80]

20.00
[508]
