Scorpion TMA Post Impact Survey Measurements

TITLE:
TMA Post Impact Measurements and Survey

SIZE B	DRAWING NO. 1086	REV E1
------------------	---------------------	------------------

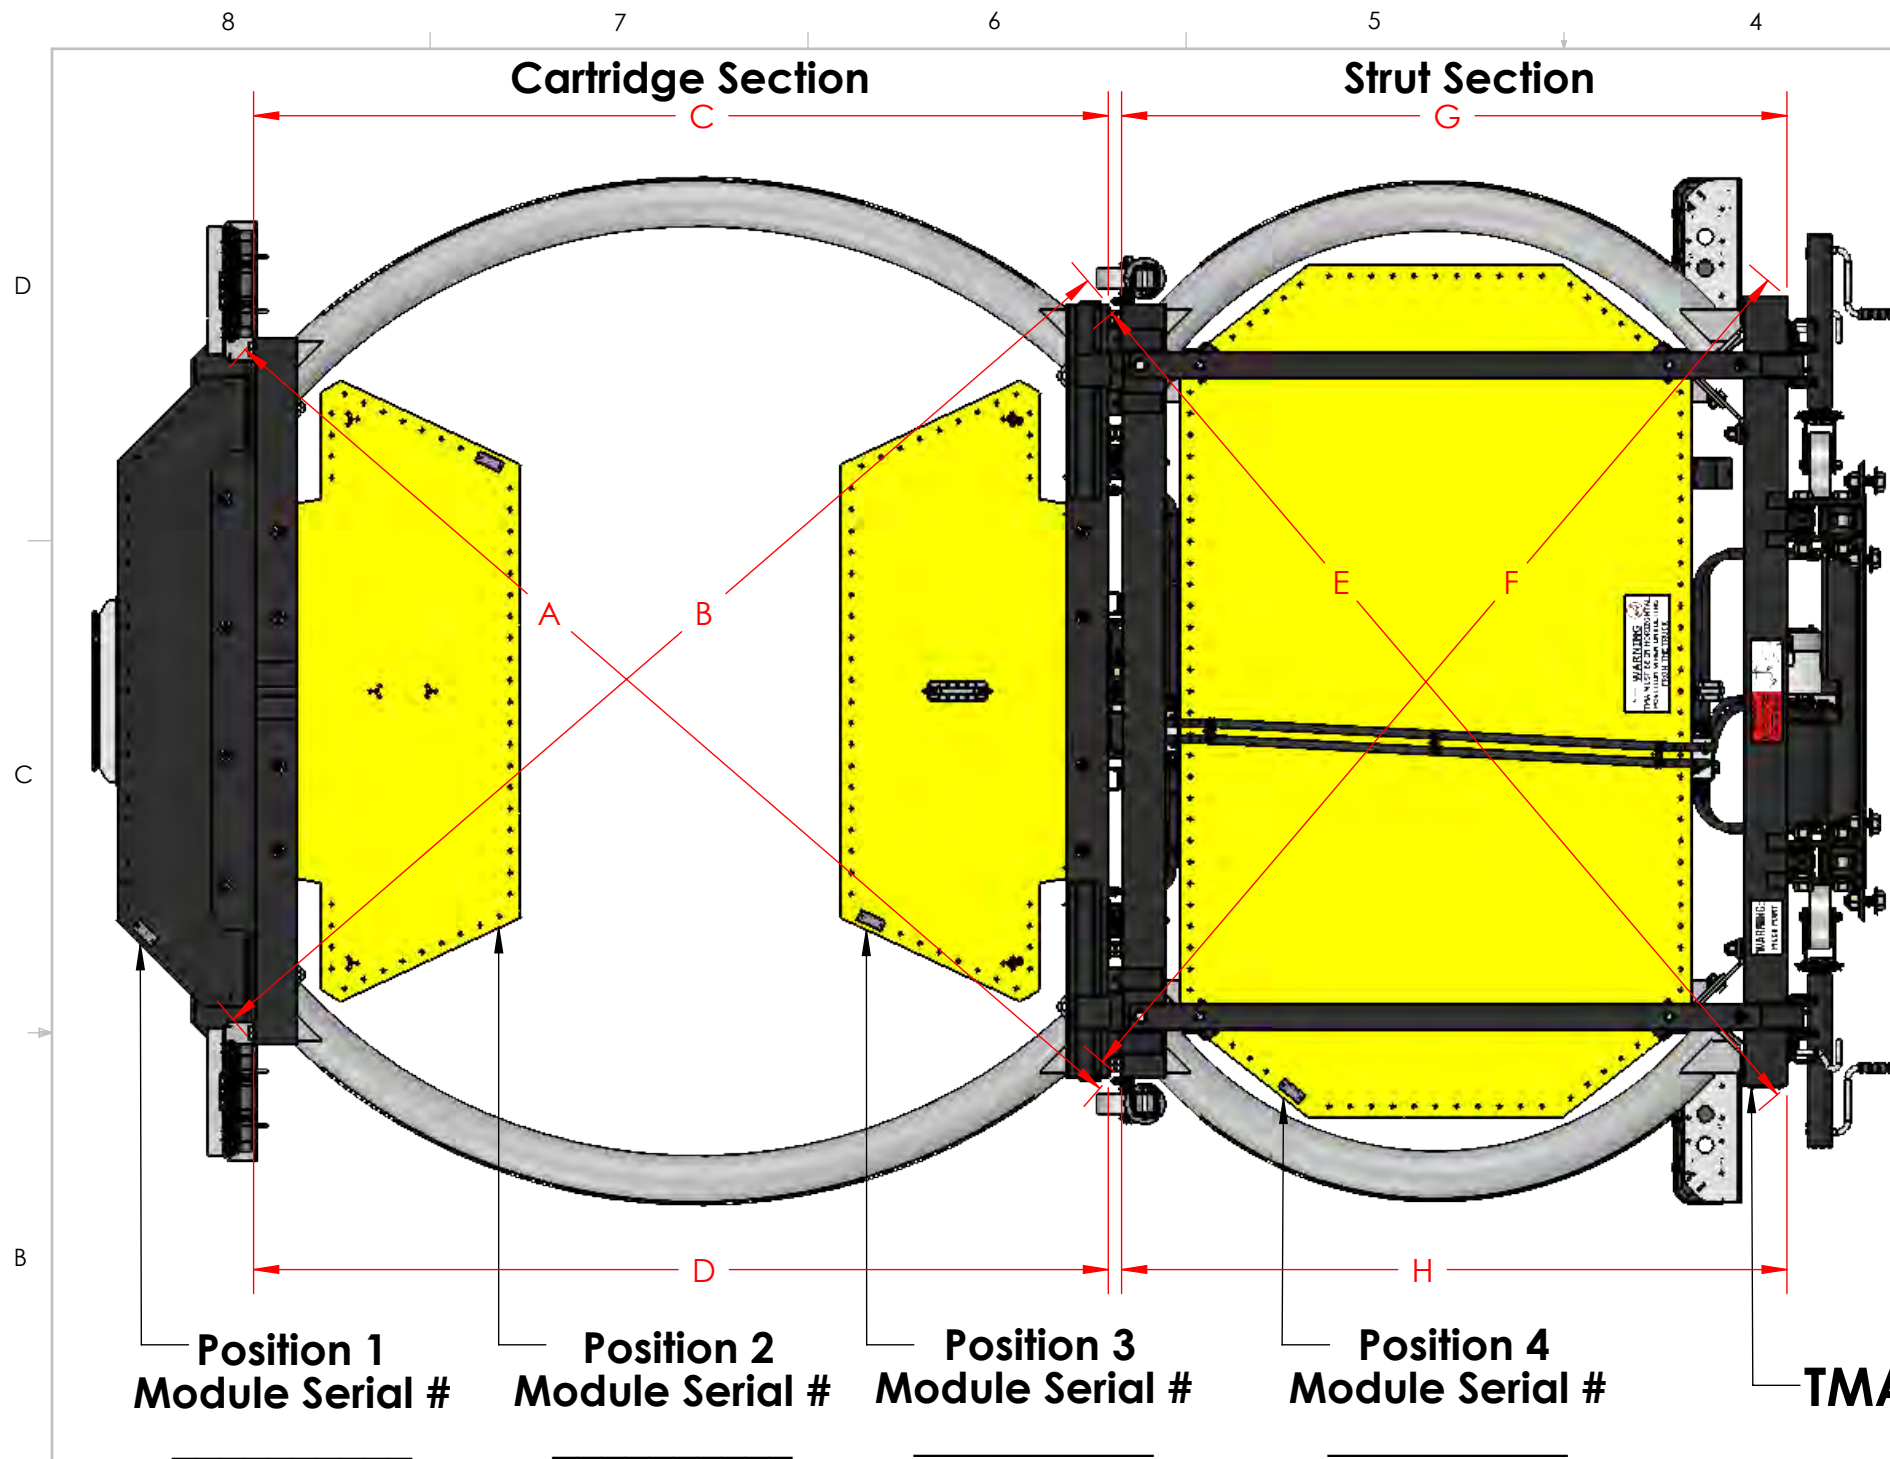
The purpose of the survey measurements is to determine whether or not the tube assemblies are still serviceable. Tube assemblies that are no longer in spec must be replaced before the TMA can be returned to service as a life saving piece of equipment.

A = _____

B = _____
As Built: 106" [2,692 mm]
Difference between A and B must be less than 1" [25 mm]

C = _____
Min: 79-3/4" [2,026 mm]
Max: 80-3/4" [2,051 mm]

D = _____
Min: 79-3/4" [2,026 mm]
Max: 80-3/4" [2,051 mm]

E = _____

F = _____
As Built: 96-1/4" [2,445 mm]
Difference between E and F must be less than 1" [25 mm]

G = _____
Min: 61-3/4" [1,569 mm]
Max: 62-3/4" [1,594 mm]

H = _____
Min: 61-3/4" [1,569 mm]
Max: 62-3/4" [1,594 mm]

- Record the TMA serial number and each energy absorbing module serial number in the spaces provided.
- Perform measurements A through H and record the values in the spaces provided.
- Dimension limits specified are valid for both NCHRP-350 tested Scorpion TMA and MASH tested Scorpion II TMA.
- All measurements must fall within the min/max values indicated for the tube assemblies to remain in service.
- If any measurements fall outside the acceptable limits, please consult with an appropriate TrafFix Devices representative.
- Any tube assemblies that are deemed "out of spec" must be destroyed by fully cutting the upper and lower tube.
- In some cases, it may be necessary to take measurements at the bottom as well as the top if damage is observed on the lower portion of the tube assemblies. Both top and bottom measurements must fall within the min/max values defined.
