# Scorpion II Metro TMA Post Impact Survey Measurements

TITLE:  
**Scorpion II Metro TMA Post Impact Measurements and Survey**

SIZE <b>B</b>	DRAWING NO. 1000-238	REV <b>A</b>
------------------	-------------------------	-----------------

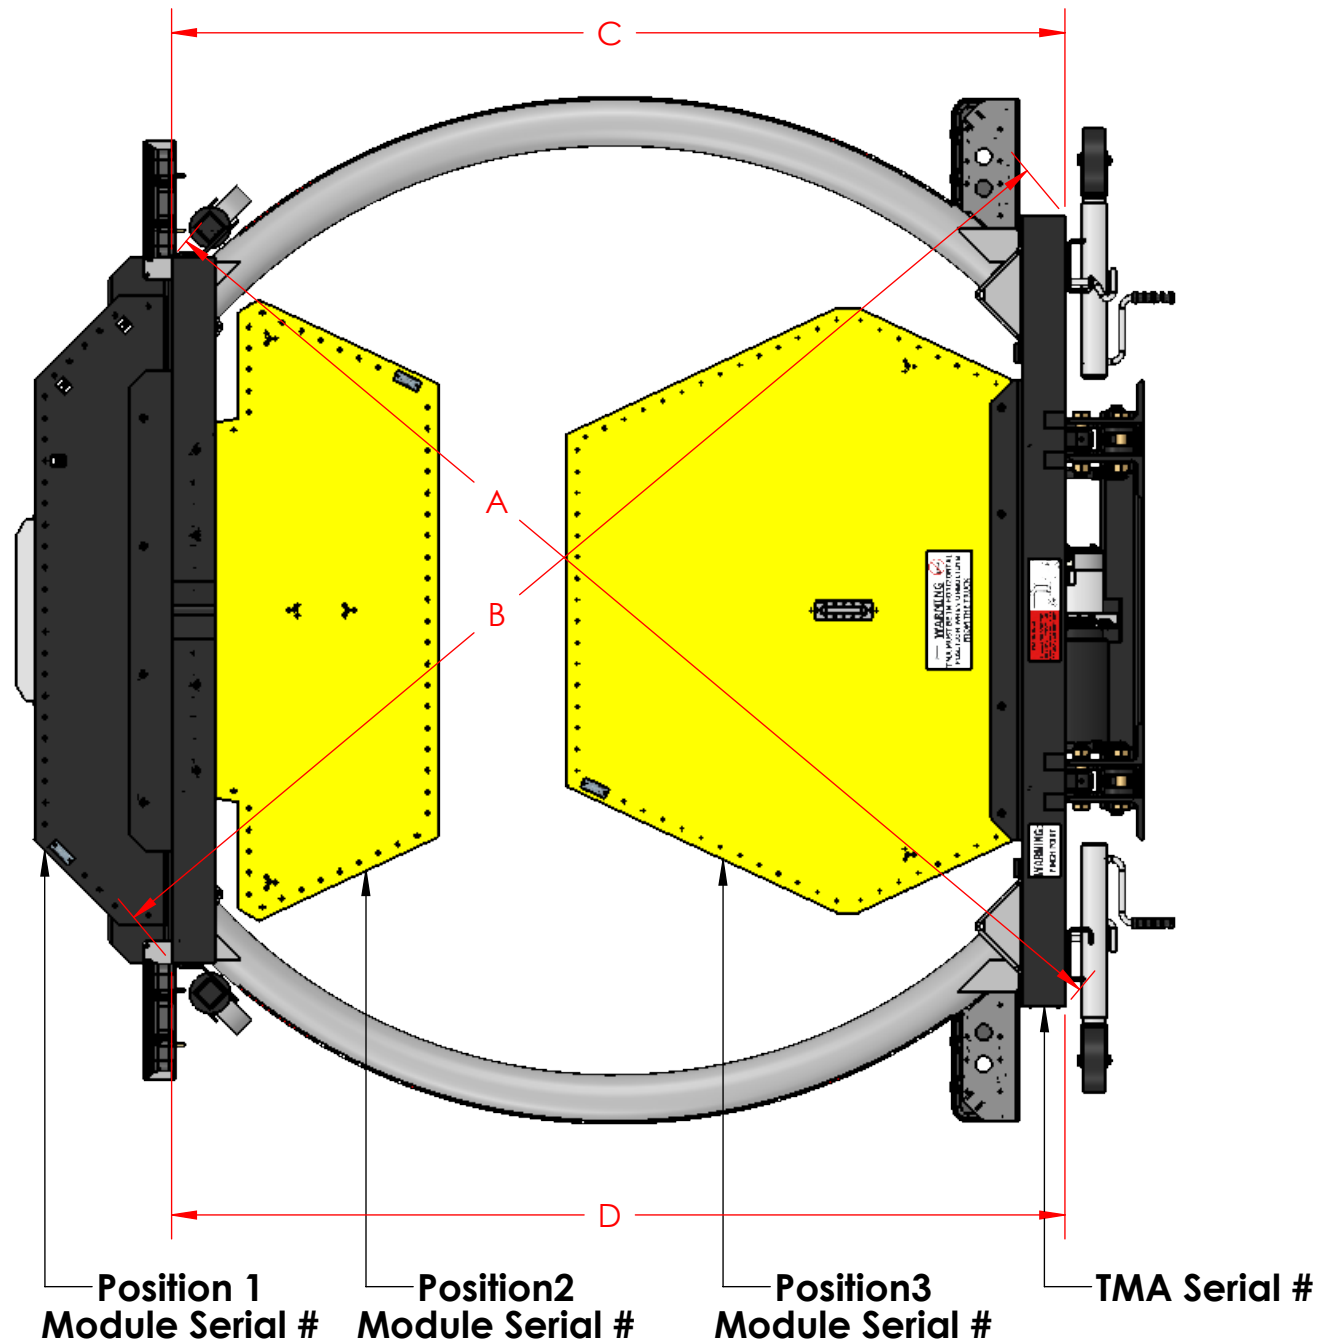
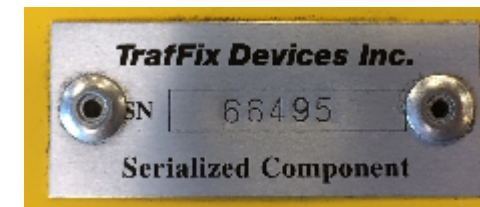
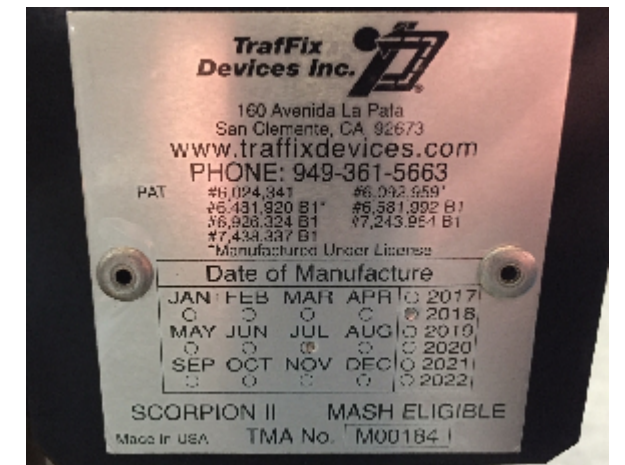
A = \_\_\_\_\_

B = \_\_\_\_\_  
**As Built: 106" [2,692 mm]**  
**Difference between A and B must be less than 1" [25 mm]**

C = \_\_\_\_\_  
**Min: 79-3/4" [2,026 mm]**  
**Max: 80-3/4" [2,051 mm]**

D = \_\_\_\_\_  
**Min: 79-3/4" [2,026 mm]**  
**Max: 80-3/4" [2,051 mm]**

- Record the Metro TMA serial number and each energy absorbing module serial number in the spaces provided.
- Perform measurements A through D and record the values in the spaces provided.
- Dimension limits specified are valid for the MASH tested Scorpion II Metro TMA.
- All measurements must fall within the min/max values indicated for the tube assemblies to remain in service.
- If any measurements fall outside the acceptable limits, please consult with an appropriate TrafFix Devices representative.
- Any tube assemblies that are deemed "out of spec" must be destroyed by fully cutting the upper and lower tube.
- In some cases, it may be necessary to take measurements at the bottom as well as the top if damage is observed on the lower portion of the tube assemblies. Both top and bottom measurements must fall within the min/max values defined.

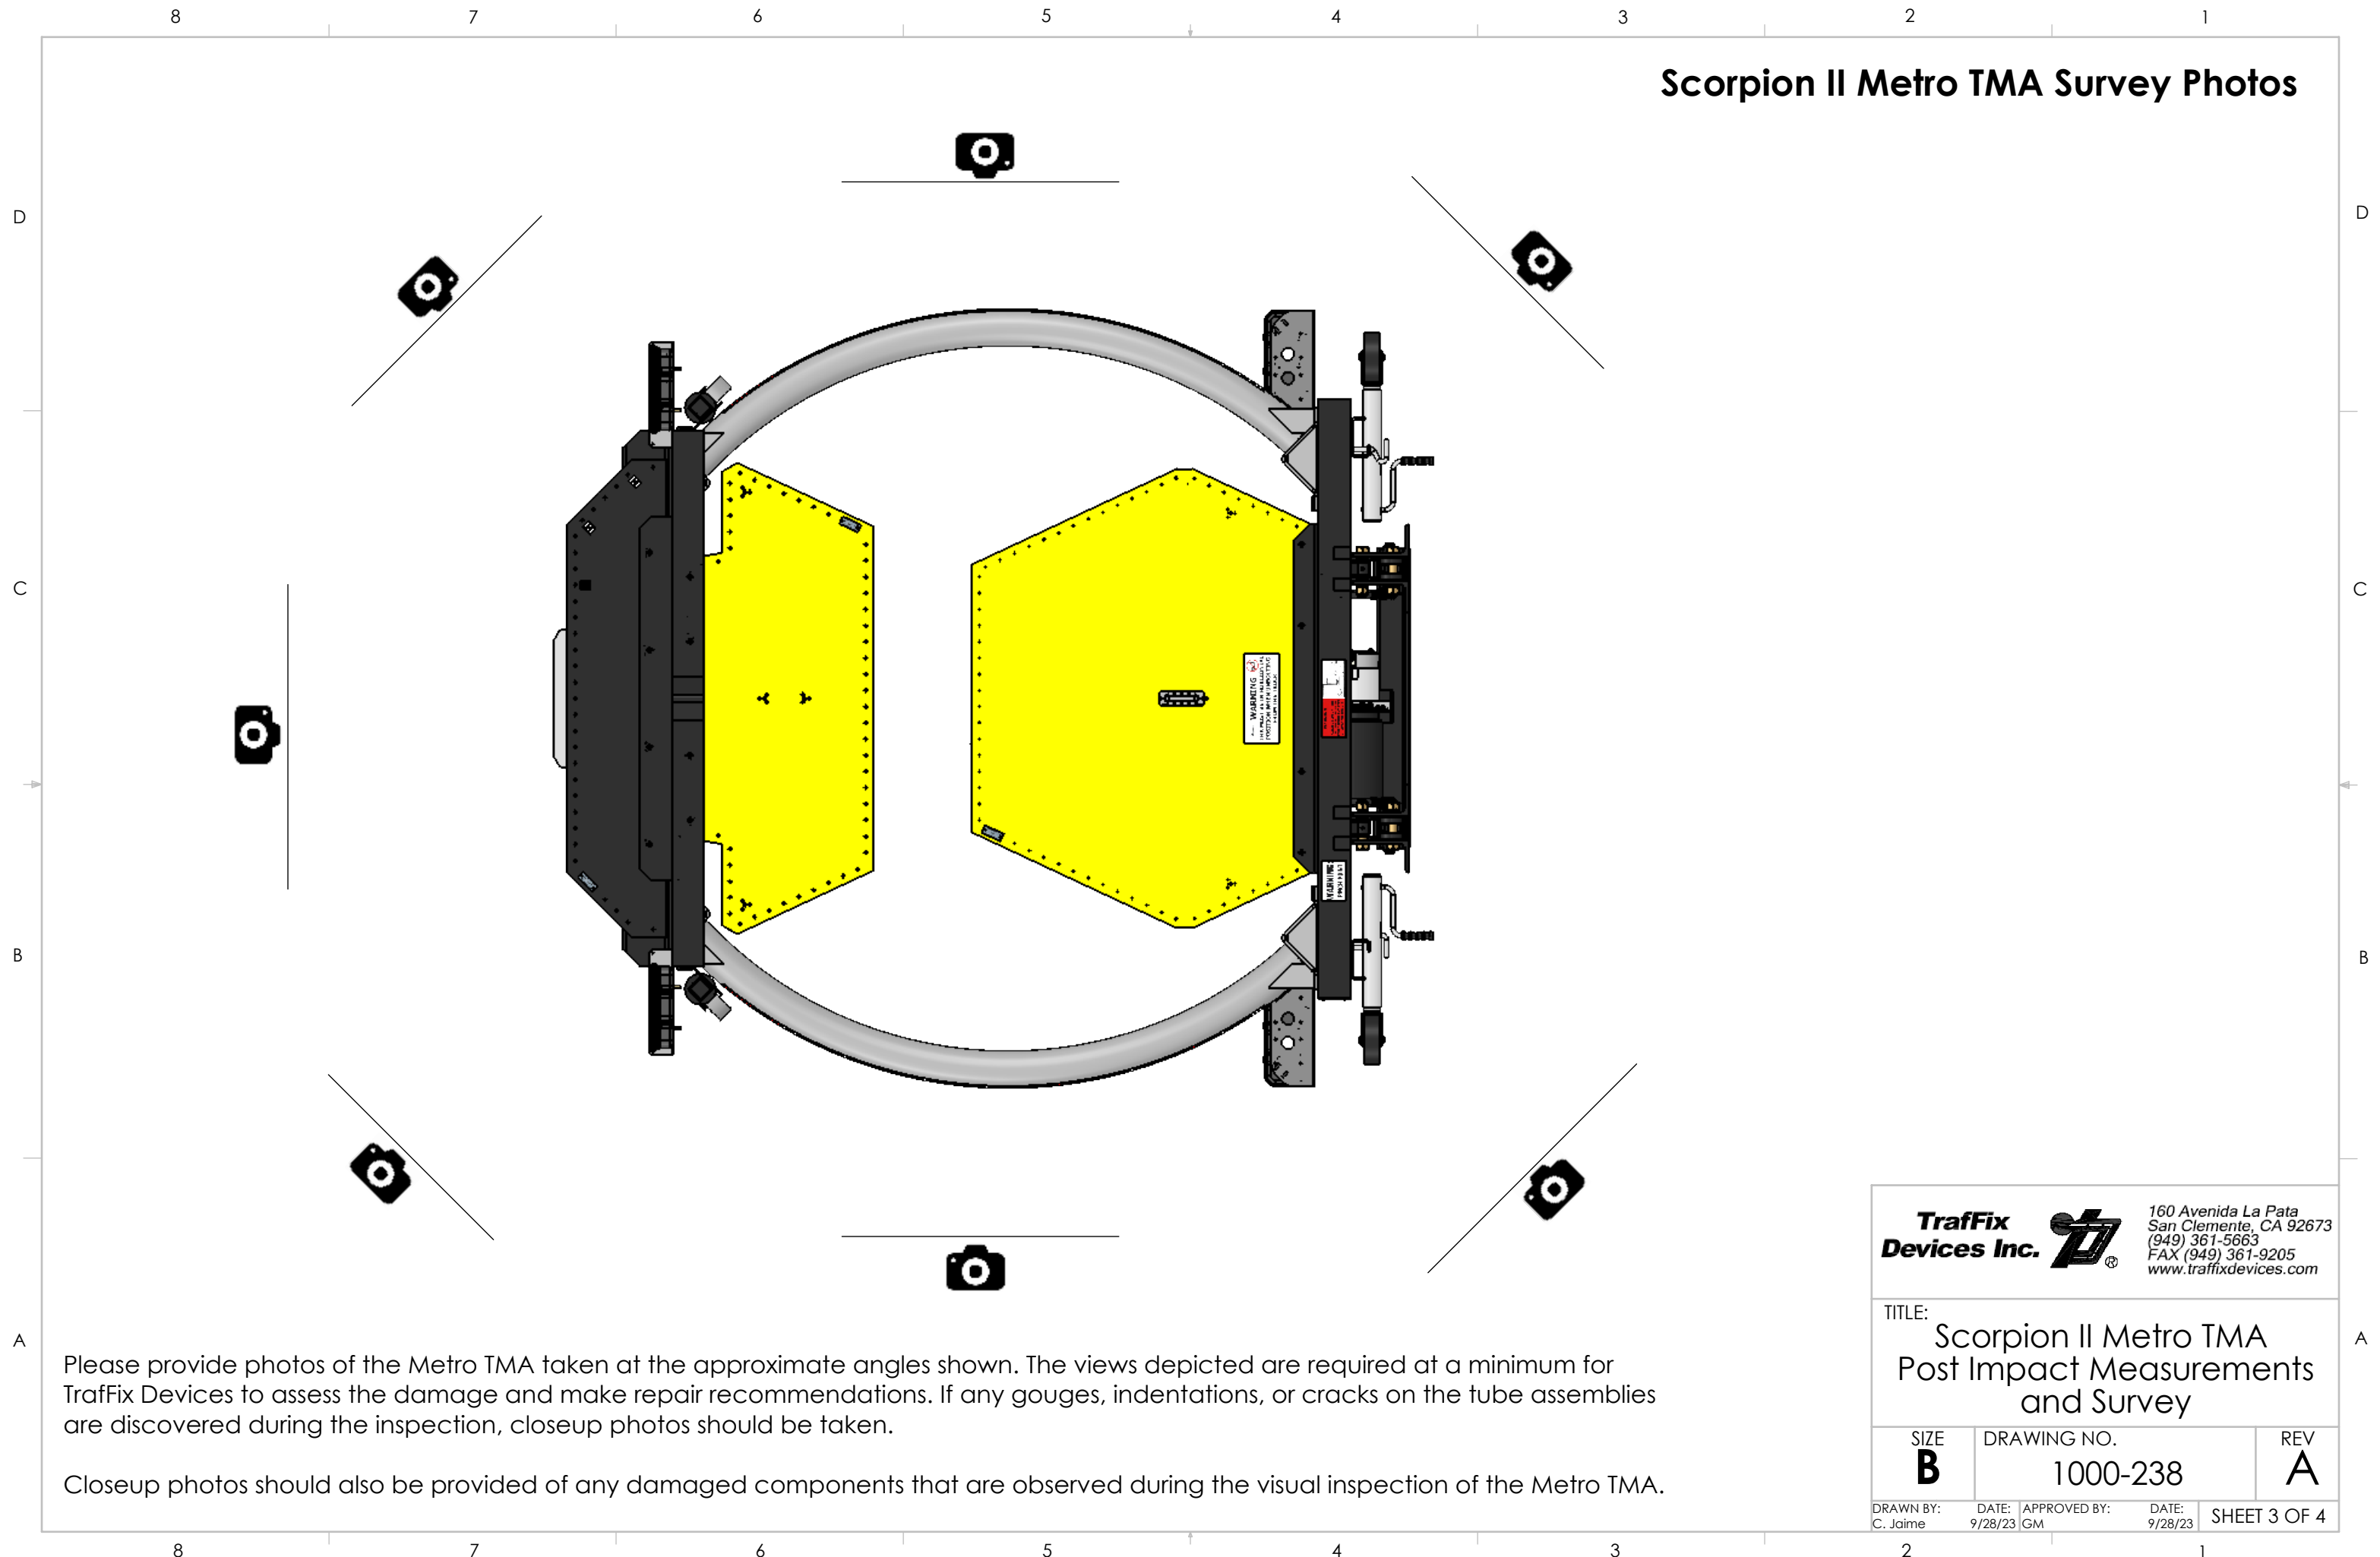
# Scorpion II Metro TMA Survey Photos

Please provide photos of the Metro TMA taken at the approximate angles shown. The views depicted are required at a minimum for Traffix Devices to assess the damage and make repair recommendations. If any gouges, indentations, or cracks on the tube assemblies are discovered during the inspection, closeup photos should be taken.

Closeup photos should also be provided of any damaged components that are observed during the visual inspection of the Metro TMA.

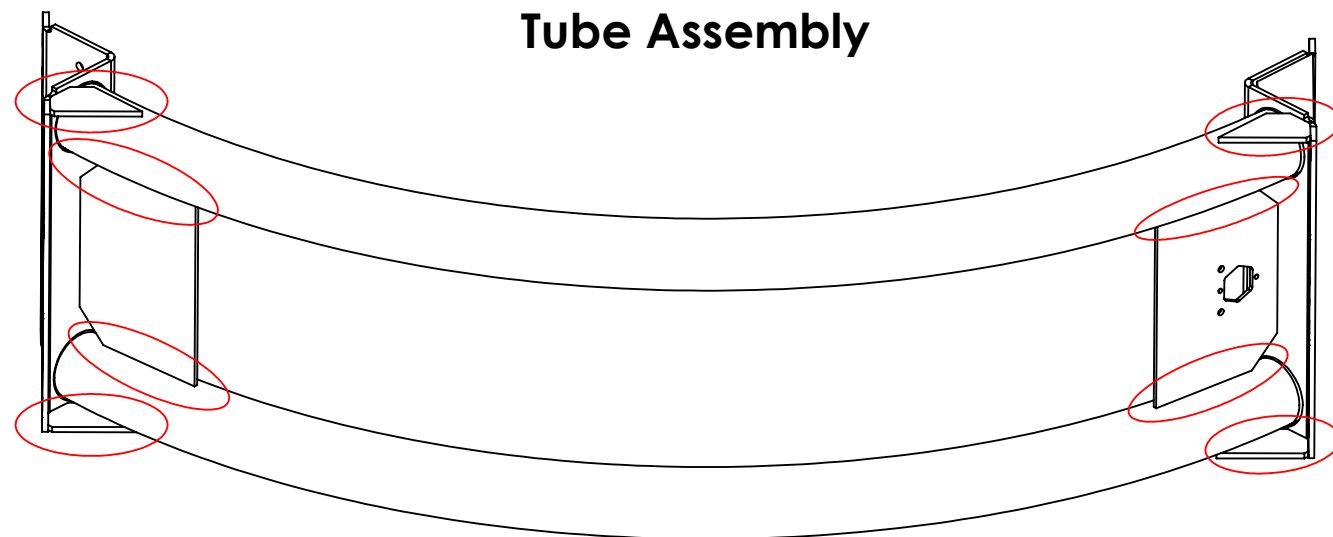
### Tube Assembly

Conduct a visual inspection of all welds on the tube assemblies. Pay close attention to the areas outlined in red. Check for the presence of cracks in the welds and the tubes themselves. Inspect for any signs of material deformation such as gouges, chips, dents, or scrapes along the entire length of the top and bottom tubes.
