**Federal Highway
Administration**

This letter is in response to your March 13, 2019 request for the Federal Highway Administration (FHWA) to review a roadside safety device, hardware, or system for eligibility for reimbursement under the Federal-aid highway program. This FHWA letter of eligibility is assigned FHWA control number CC-155 and is valid until a subsequent letter is issued by FHWA that expressly references this device.

- SLED to MGS Guardrail

Name of system: SLED to MGS Guardrail
Type of system: Crash Cushion
Test Level: MASH Test Level 3 (TL3)
Testing conducted by: KARCO
Date of request: March 13, 2019

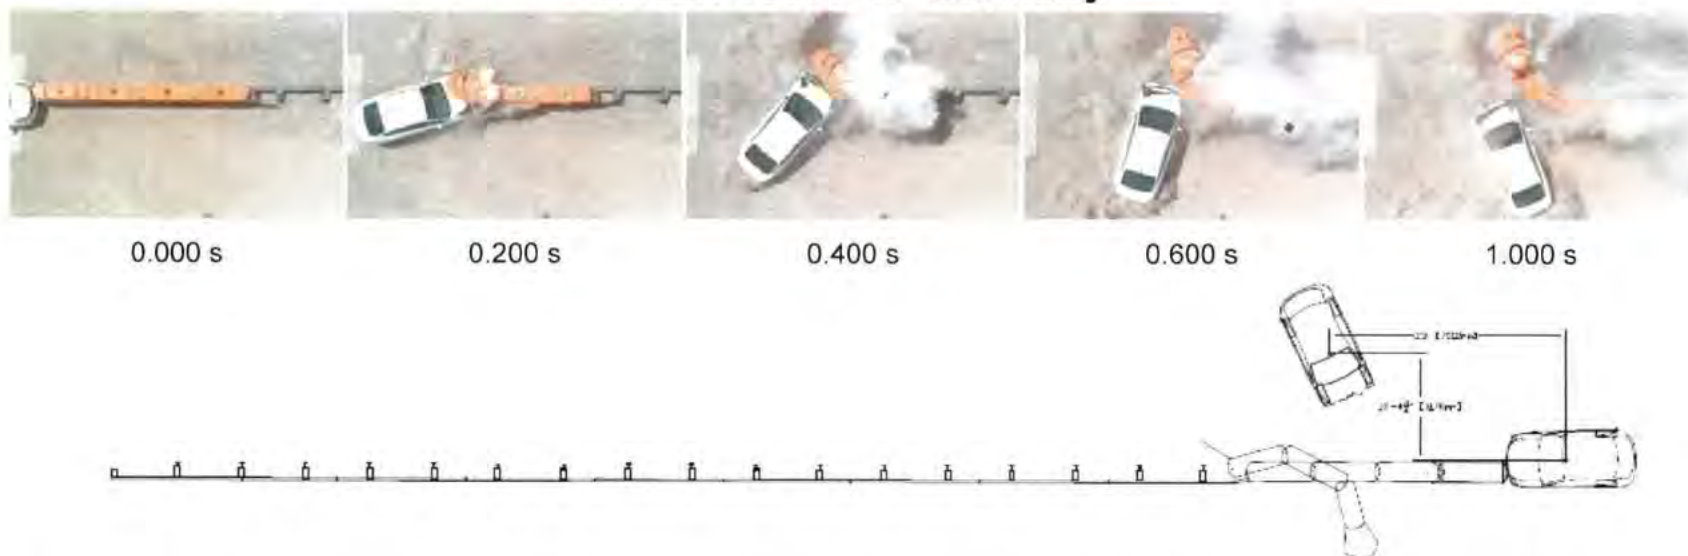
Figure 2 Summary of Test 3-40

General Information	
Test Agency.....	KARCO Engineering, LLC.
KARCO Test No.....	P37262-01
Test Designation.....	3-40
Test Date.....	07/23/17
Test Article	
Name / Model.....	SLED Attached to Guardrail
Type.....	Crash Cushion
Article Length.....	25.0 ft. (7.6 m)
Installation Length.....	136.1 ft. (41.5 m)
Road Surface.....	Medium to Fine Silty Soil
Test Vehicle	
Type / Designation.....	1100C
Year, Make, and Model.....	2013 Kia Rio
Curb Mass.....	2,554.0 lbs (1,158.5 kg)
Test Inertial Mass.....	2,471.3 lbs (1,121.0 kg)
Gross Static Mass.....	2,627.9 lbs (1,192.0 kg)

Impact Conditions	
Impact Velocity.....	62.78 mph (101.03 km/h)
Impact Angle.....	0.5°
Location / Orientation.....	Offset 16.8 in. (428 mm)
Kinetic Energy.....	325.6 kip-ft (441.5 kJ)
Exit Conditions	
Exit Velocity.....	N/A
Exit Angle.....	N/A
Final Vehicle Position.....	23.0 ft. (7.0 m) downstream 10.4 ft. (3.2 m) right
Vehicle Snagging.....	None
Vehicle Pocketing.....	None
Vehicle Stability.....	Satisfactory
Maximum Roll Angle.....	-8.1°
Maximum Pitch Angle.....	5.2°
Maximum Yaw Angle.....	-113.7°

Occupant Risk	
Longitudinal OIV.....	10.6 m/s (34.8 ft/s)
Lateral OIV.....	0.3 m/s (1.0 ft/s)
Longitudinal RA.....	-18.6 g
Lateral RA.....	-1.8 g
THIV.....	10.5 m/s (34.4 ft/s)
PHD.....	18.2 g
ASI.....	1.18
Test Article Deflections	
Static.....	7.2 ft. (2.2 m)
Dynamic.....	7.2 ft. (2.2 m)
Working Width.....	9.4 ft. (2.9 m)
Debris Field.....	65.9 ft. (20.0 m) downstream 24.3 ft. (7.4 m) right
Vehicle Damage	
Vehicle Damage Scale.....	12-FD-4
CDC.....	12FDEW4
Maximum Intrusion.....	0.8 in. (19 mm)

Required Test Number	Narrative Description	Evaluation Results
3-40 (1100C)	<p>The SLED was positioned offset a quarter of the vehicle's width towards the passenger side. The offset position examines the risk of exceeding occupant risk values, vehicle instability, and vehicle yaw movement. The test was conducted using a commercially available 2013 Kia Rio 4-door sedan with a test inertial mass of 2,471.3 lbs. (1,121.0 kg). The test vehicle impacted the SLED at a velocity of 62.78 mph (101.03 km/h) and at an impact angle of 0.5°. The test vehicle impacted the steel Containment Impact Sled (CIS), pushing it rearward crushing and rupturing the yellow empty module within the CIS. As the vehicle continued downstream the three yellow water filled modules were crushed, ruptured, and dispersed the contained water. The vehicle rotated in a counter clockwise direction about its yaw axis before coming to a controlled stop 23.0 ft. (7.0 m) forward and 10.4 ft. (3.2 m) lateral from the initial point of impact. The yellow SLED modules remained tethered together and securely attached to the guardrail via the steel t-pins between the module knuckles which connects directly to the internal molded in steel cables. The impacting vehicle was brought to a controlled stop, remained upright and did not exhibit vaulting throughout the impact event. The test vehicle's occupant compartment was not penetrated and there was no in cab deformation beyond allowable limits. The maximum roll and pitch angle did not exceed 75° and occupant risk values were within limits per MASH specifications for Occupant Impact Velocity (OIV) and Ridedown Acceleration (RA). The SLED attached to guardrail met all the requirements of MASH Test 3-40.</p>	PASS

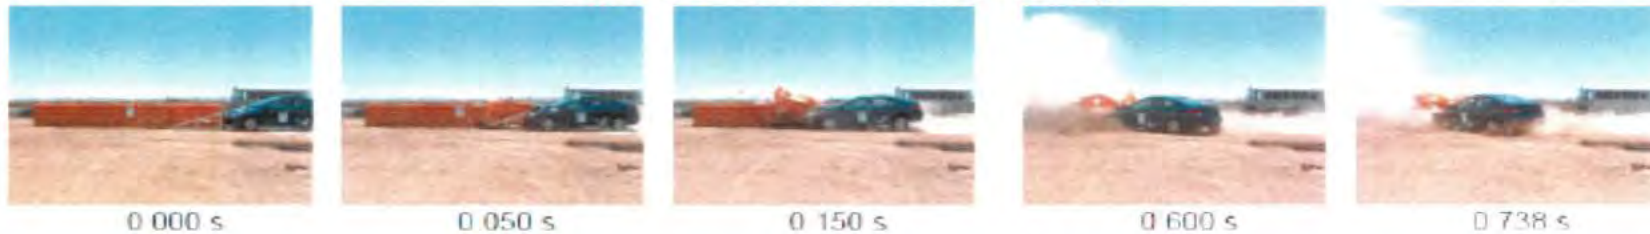
Figure 2 Summary of Test 3-42

General Information	
Test Agency.....	IDIADA KARCO
Test No.....	P38130-01
Test Designation.....	3-42
Test Date.....	05/18/18
Test Article	
Name / Model.....	SLED Attached to Guardrail
Type.....	Non-Redirective Crash Cushion
Article Length.....	25.0 ft (7.6 m)
Installation Length.....	136.1 ft (41.5 m)
Road Surface.....	Compacted Soil
Test Vehicle	
Type / Designation.....	1100C
Year, Make, and Model.....	2016 Hyundai Accent
Curb Mass.....	2,451.5 lbs (1,112.0 kg)
Test Inertial Mass.....	2,426.1 lbs (1,100.5 kg)
Gross Static Mass.....	2,588.2 lbs (1,174.0 kg)

Impact Conditions	
Impact Velocity.....	61.99 mph (99.76 km/h)
Impact Angle.....	4.2°
Location / Orientation.....	Center of CG
Kinetic Energy.....	311.7 kip-ft (422.6 kJ)
Exit Conditions	
Exit Velocity.....	N/A
Exit Angle.....	N/A
Final Vehicle Position.....	15.7 ft (4.8 m) downstream
Exit Box Criteria Met.....	N/A
Vehicle Snagging.....	None
Vehicle Pocketing.....	None
Vehicle Stability.....	Satisfactory
Maximum Roll Angle.....	7.7°
Maximum Pitch Angle.....	-5.0°
Maximum Yaw Angle.....	51.3°

Occupant Risk	
Longitudinal OIV.....	33.0 ft/s (10.3 m/s)
Lateral OIV.....	1.0 ft/s (0.3 m/s)
Longitudinal RA.....	-19.5 g
Lateral RA.....	-4.8 g
THIV.....	33.8 ft/s (10.3 m/s)
PHD.....	18.9 g
ASI.....	1.20
Test Article Deflections	
Static.....	0.7 ft (0.2 m)
Dynamic.....	5.4 ft (1.6 m)
Working Width.....	11.1 ft (3.4 m)
Debris Field.....	25.5 ft (26.0 m) downstream
	34.8 ft (10.6 m) Left
Vehicle Damage	
Vehicle Damage Scale.....	12-FD-4
CDC.....	12FDEW4
Maximum Intrusion.....	0.1 in. (3 mm)

3-42 (1100C)	<p>The SLED was positioned at a nominal angle of 5° with the centerline of the test vehicle aligned with the nose of the system. The angled position examines the risk of exceeding occupant risk values, vehicle instability, capacity to absorb sufficient impact energy, and the SLED's ability to bring the vehicle to a controlled stop. The test was conducted using a commercially available 2016 Hyundai Accent 4-door sedan with a test inertial mass of 2,426.1 lbs. (1,100.5 kg). The test vehicle impacted the SLED at a velocity of 61.99 mph (99.76 km/h) and at an impact angle of 4.2°. The test vehicle impacted the steel Containment Impact Sled (CIS), pushing it downstream crushing and rupturing the yellow empty module within the CIS. As the vehicle continued downstream the three yellow water filled modules were crushed, ruptured, and dispersed the contained water. The vehicle rotated in a clockwise direction about its yaw axis before coming to a controlled stop 15.7 ft. (4.8 m) downstream and 5.8 ft. (1.8 m) lateral from the initial point of impact. The yellow SLED modules remained tethered together and securely attached to the guardrail via the steel t-pins between the module knuckles which connects directly to the internal molded in steel cables. The impacting vehicle was brought to a controlled stop, remained upright and did not exhibit vaulting throughout the impact event. The test vehicle's occupant compartment was not penetrated and there was no in cab deformation beyond allowable limits. The maximum roll and pitch angle did not exceed 75° and occupant risk values were within limits per MASH specifications for Occupant Impact Velocity (OIV) and Ridedown Acceleration (RA). The SLED attached to guardrail met all the requirements of MASH Test 3-42.</p>	PASS

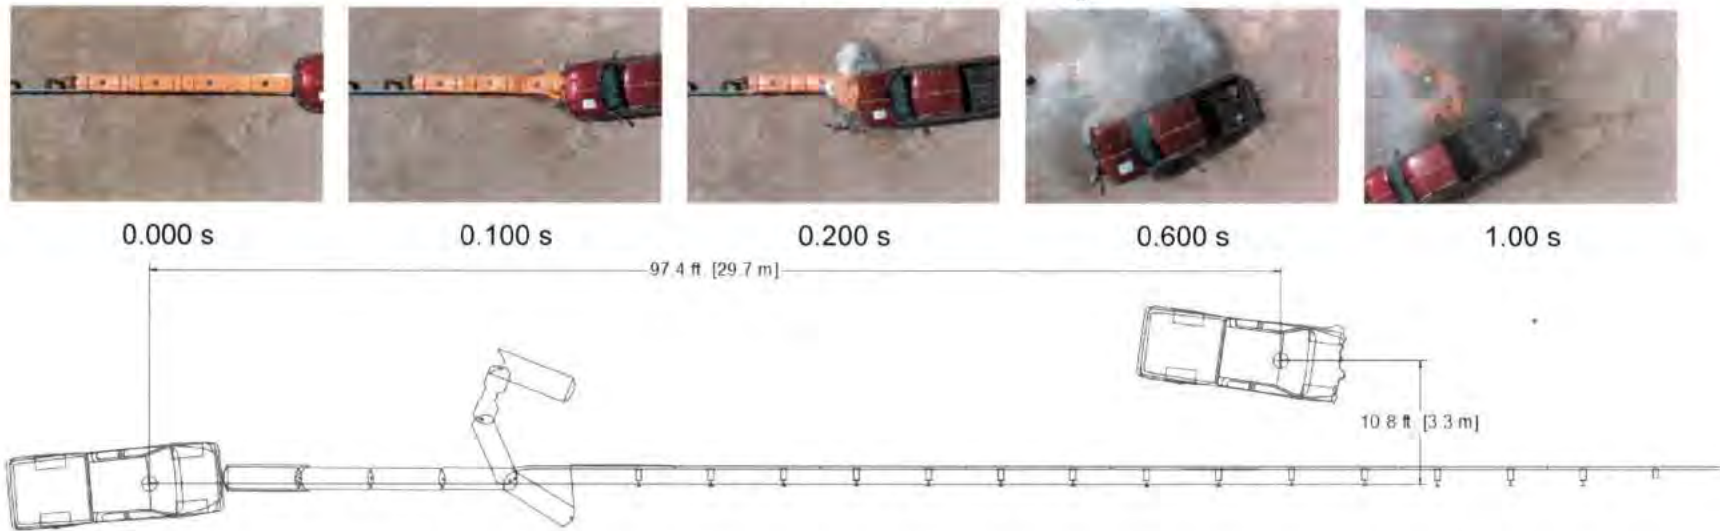
Figure 2 Summary of Test 3-43

General Information	
Test Agency.....	IDIADA KARCO
Test No.....	P38132-01
Test Designation.....	3-43
Test Date.....	05/24/18
Test Article	
Name / Model.....	SLED Attached to GR
Type.....	Non-Redirective Crash Cushion
Article Length.....	25.3 ft. (7.7 m)
Installation Length.....	131.4 ft. (40.1 m)
Road Surface.....	Compacted Soil
Test Vehicle	
Type / Designation.....	2270P
Year, Make, and Model.....	2013 RAM 1500
Curb Mass.....	4,883.2 lbs (2,215.0 kg)
Test Inertial Mass.....	5,003.3 lbs (2,269.5 kg)
Gross Static Mass.....	5,003.3 lbs (2,269.5 kg)

Impact Conditions	
Impact Velocity.....	63.22 mph (101.75 km/h)
Impact Angle.....	5.4°
Location / Orientation.....	Center of CIS
Kinetic Energy.....	668.5 kip-ft (906.4 kJ)
Exit Conditions	
Exit Velocity.....	14.04 mph (22.60 km/h)
Exit Angle.....	11.2°
Final Vehicle Position.....	97.4 ft. (29.7 m) dw
	10.8 ft. (3.3 m) Left
Vehicle Snagging.....	None
Vehicle Pocketing.....	None
Vehicle Stability.....	Satisfactory
Maximum Roll Angle.....	8.8°
Maximum Pitch Angle.....	23.8°
Maximum Yaw Angle.....	-22.9°

Occupant Risk	
Longitudinal OIV.....	32.2 ft/s (9.8 m/s)
Lateral OIV.....	2.6 ft/s (0.8 m/s)
Longitudinal RA.....	-12.8 g
Lateral RA.....	-3.9 g
THIV.....	32.2 ft/s (9.8 m/s)
PHD.....	12.0 g
ASI.....	0.88
Test Article Deflections	
Static.....	7.8 ft. (2.4 m)
Dynamic.....	8.2 ft. (2.5 m)
Working Width.....	16.4 ft. (5.0 m)
Debris Field.....	110.9 ft. (33.8 m) downstream
	29.8 ft. (9.1 m) Left
Vehicle Damage	
Vehicle Damage Scale.....	12-FD-4
CDC.....	12FDEW4
Maximum Intrusion.....	0.2 in. (6 mm)

3-43 (2270P)	<p>The SLED was positioned at a nominal angle of 5° with the centerline of the test vehicle aligned with the nose of the system. The angled position examines the risk of exceeding occupant risk values, vehicle instability, capacity to absorb sufficient impact energy, and the SLED's ability to bring the vehicle to a controlled stop. The test was conducted using a commercially available 2013 RAM 1500 4-door pickup truck with a test inertial mass of 5,003.3 lbs. (2,269.5 kg). The test vehicle impacted the crash cushion at a velocity of 63.22 mph (101.75 km/h) and at an impact angle of 5.4°. The test vehicle impacted the steel Containment Impact Sled (CIS), pushing it rearward crushing and rupturing the yellow empty module within the CIS. As the vehicle continued rearward the three yellow water filled modules were crushed, ruptured, and dispersed the contained water. The vehicle rotated in a clockwise direction about its yaw axis before coming to a controlled stop 97.4 ft. (29.7 m) forward and 10.8 ft. (3.3 m) lateral from the initial point of impact. The yellow SLED modules remained tethered together and securely attached to the guardrail via the steel t-pins between the module knuckles which connects directly to the internal molded in steel cables. The impacting vehicle was brought to a controlled stop, remained upright and did not exhibit vaulting throughout the impact event. The test vehicle's occupant compartment was not penetrated and there was no in cab deformation beyond allowable limits. The maximum roll and pitch angle did not exceed 75° and occupant risk values were within limits per MASH specifications for Occupant Impact Velocity (OIV) and Ridedown Acceleration (RA). The SLED attached to guardrail met all the requirements of MASH Test 3-43.</p>	PASS

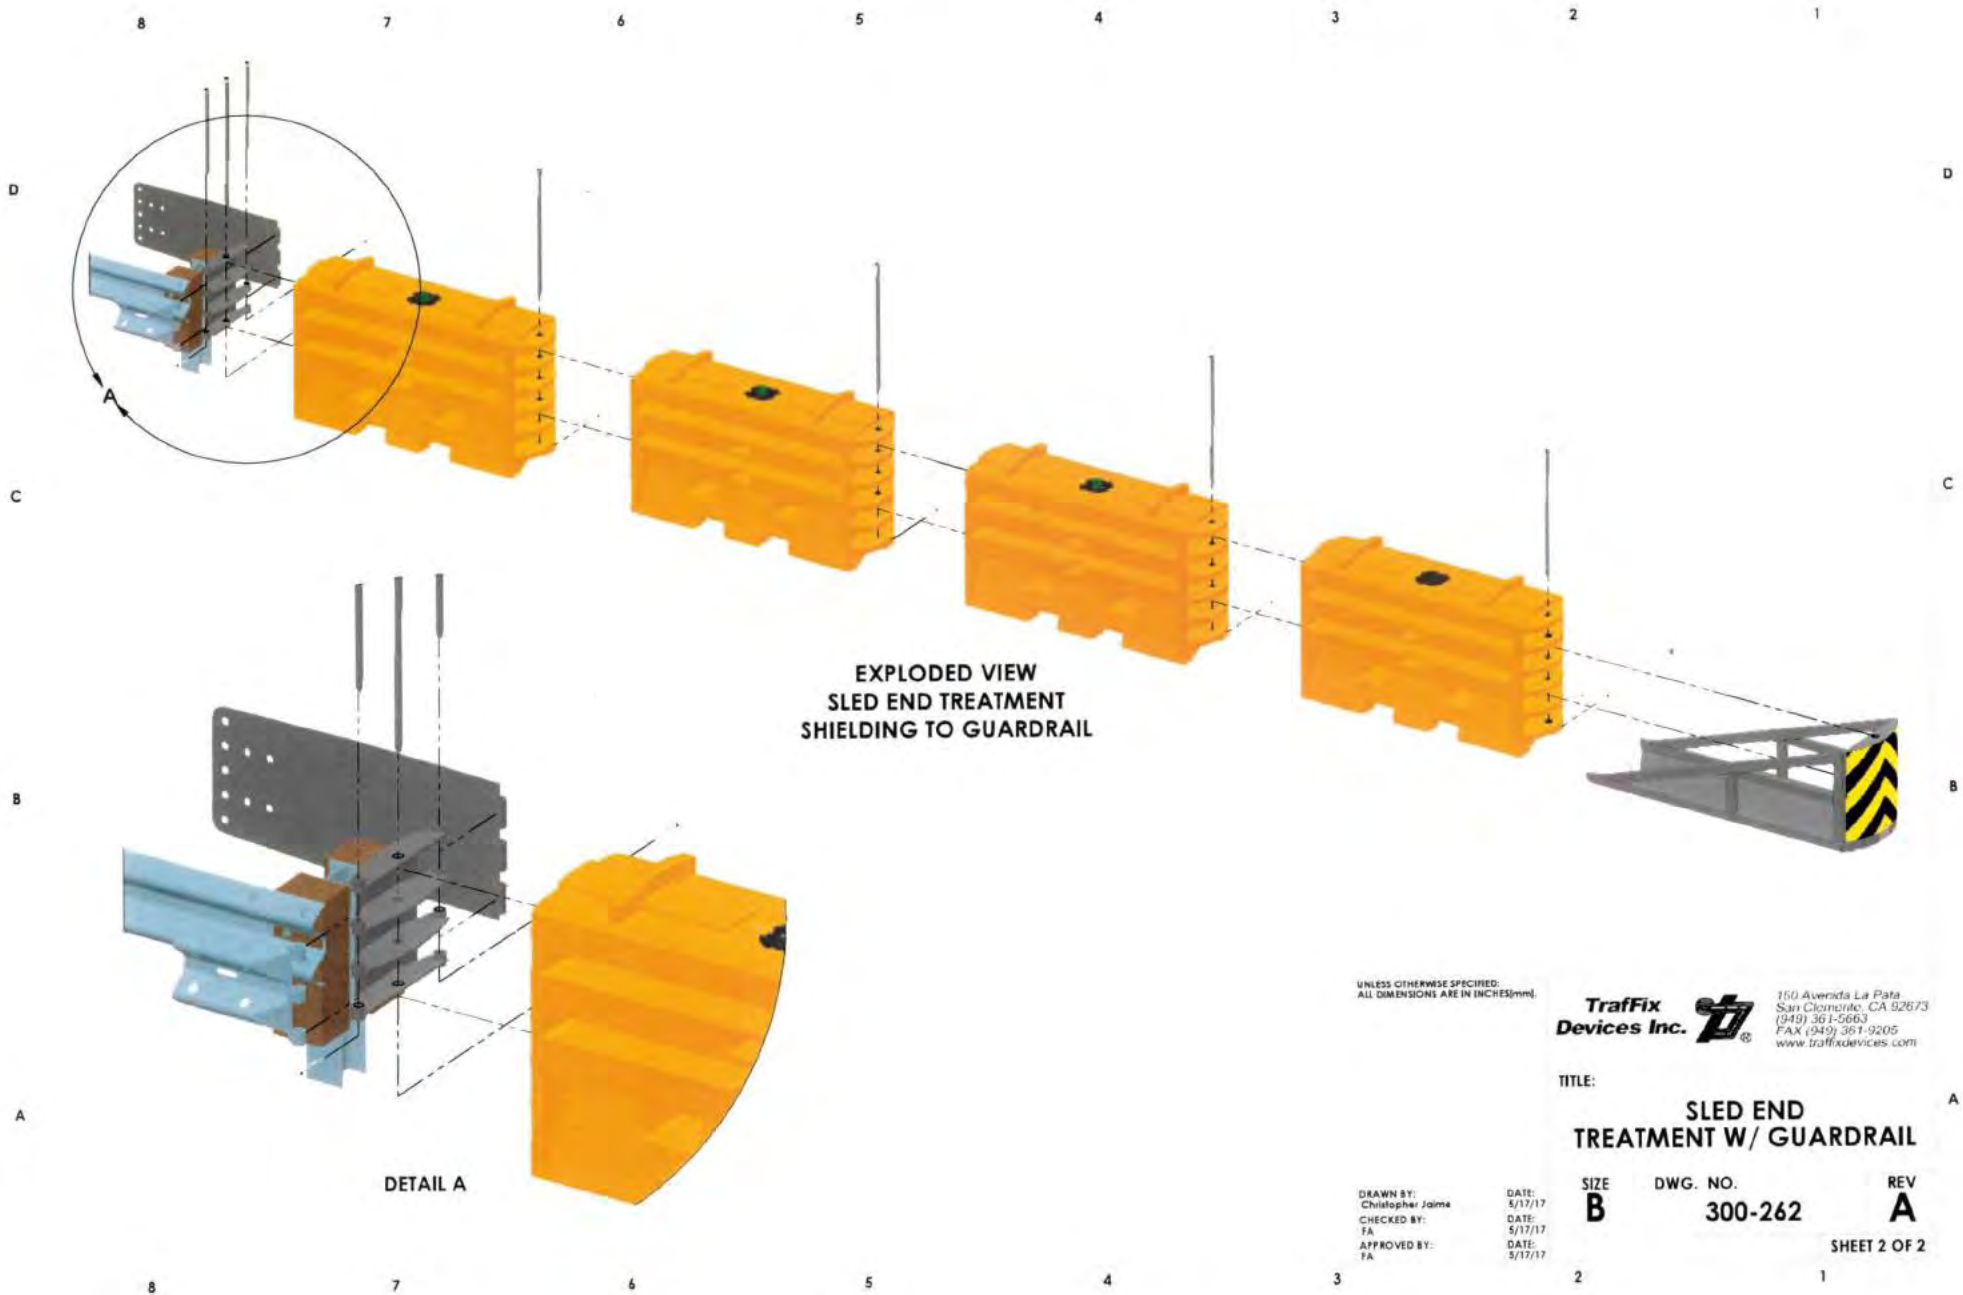
DWG. NO.
300-262

**SLED END
TREATMENT W/ GUARDRAIL**

The SLED is a free standing, non-redirective, gating crash cushion, designed to shield the end of guardrail. The SLED does not require anchoring to the road surface and can be used on concrete, asphalt, gravel, and dirt surfaces. The SLED was tested on a dirt surface. The SLED can be used in TL-1, TL-2, and TL-3 installations to treat the end of guardrail. The SLED attached to guardrail test series was conducted at TL-3 conditions. The SLED utilizes a transition that is mechanically attached to the guardrail it is shielding. The SLED system consists of four main components: three yellow water filled modules, one yellow empty module, one Containment Impact Sled (CIS), and one transition. The SLED's overall dimensions are 25.25 ft. (7.7 m) long (pin to pin) x 27.25 in. (0.7 m) wide x 45.875 in. (1.2 m) tall. The yellow modules are manufactured from polyethylene that is UV stabilized. The SLED system consists of three water filled modules with the front empty module connected to the steel CIS. The water filled modules weigh approx. 2,000 lbs. (907 kg) when filled. The SLED's yellow water filled modules contain a fill lid, which incorporates a pop-up float water level indicator for identifying that modules are filled to the appropriate level. Permanently molded within the plastic modules are four corrosion resistant cables. The modules are designed with knuckles at the ends which contains a series of vertically aligned concentric holes that allow a steel t-pin to be inserted to connect adjacent modules together. When modules are pinned together there are a total of eleven knuckles aligned with the steel t-pin inserted. At the front of the SLED system is the steel CIS that is connected to the front yellow empty module. The CIS is designed using a steel tube frame and sheet metal construction. The front yellow empty module is connected to the CIS through the vertically aligned concentric holes in the knuckles and the t-pin connects the module and the CIS together. This is the same connection method used between the three yellow water filled modules. Bolted to the front impact face on the CIS is the directional indicator panel. The directional indicator panel is a square sheet of plastic that contains gore point directional sheeting on one side and left, or right, directional sheeting on the opposite side. This allows the user to convert the panel to the proper direction when installing the SLED. The directional indicator panel contours to the curved shape on the front impact face on the CIS and is secured by six bolts. Other directional sheeting and markings are available. The SLED is attached to the guardrail using a w-beam transition panel and a standard panel attached to the w-beam. The SLED transition is made of three components: one steel transition frame, one standard transition panel, and one w-beam transition panel. The transition frame is positively connected to the rear most water filled module through the vertically aligned concentric holes in the knuckles using a steel drop pin. This is the same connection method used between the yellow water filled modules and between the CIS and the front yellow empty module. The transition panels are pinned to the transition frame using outboard alignment pins designed into the transition frame. The transition panel is attached to the guardrail panel using eight guardrail bolts. The standard transition panel and w-beam transition panels are also connected to the w-beam using one guardrail post bolt and two wooden blockouts.

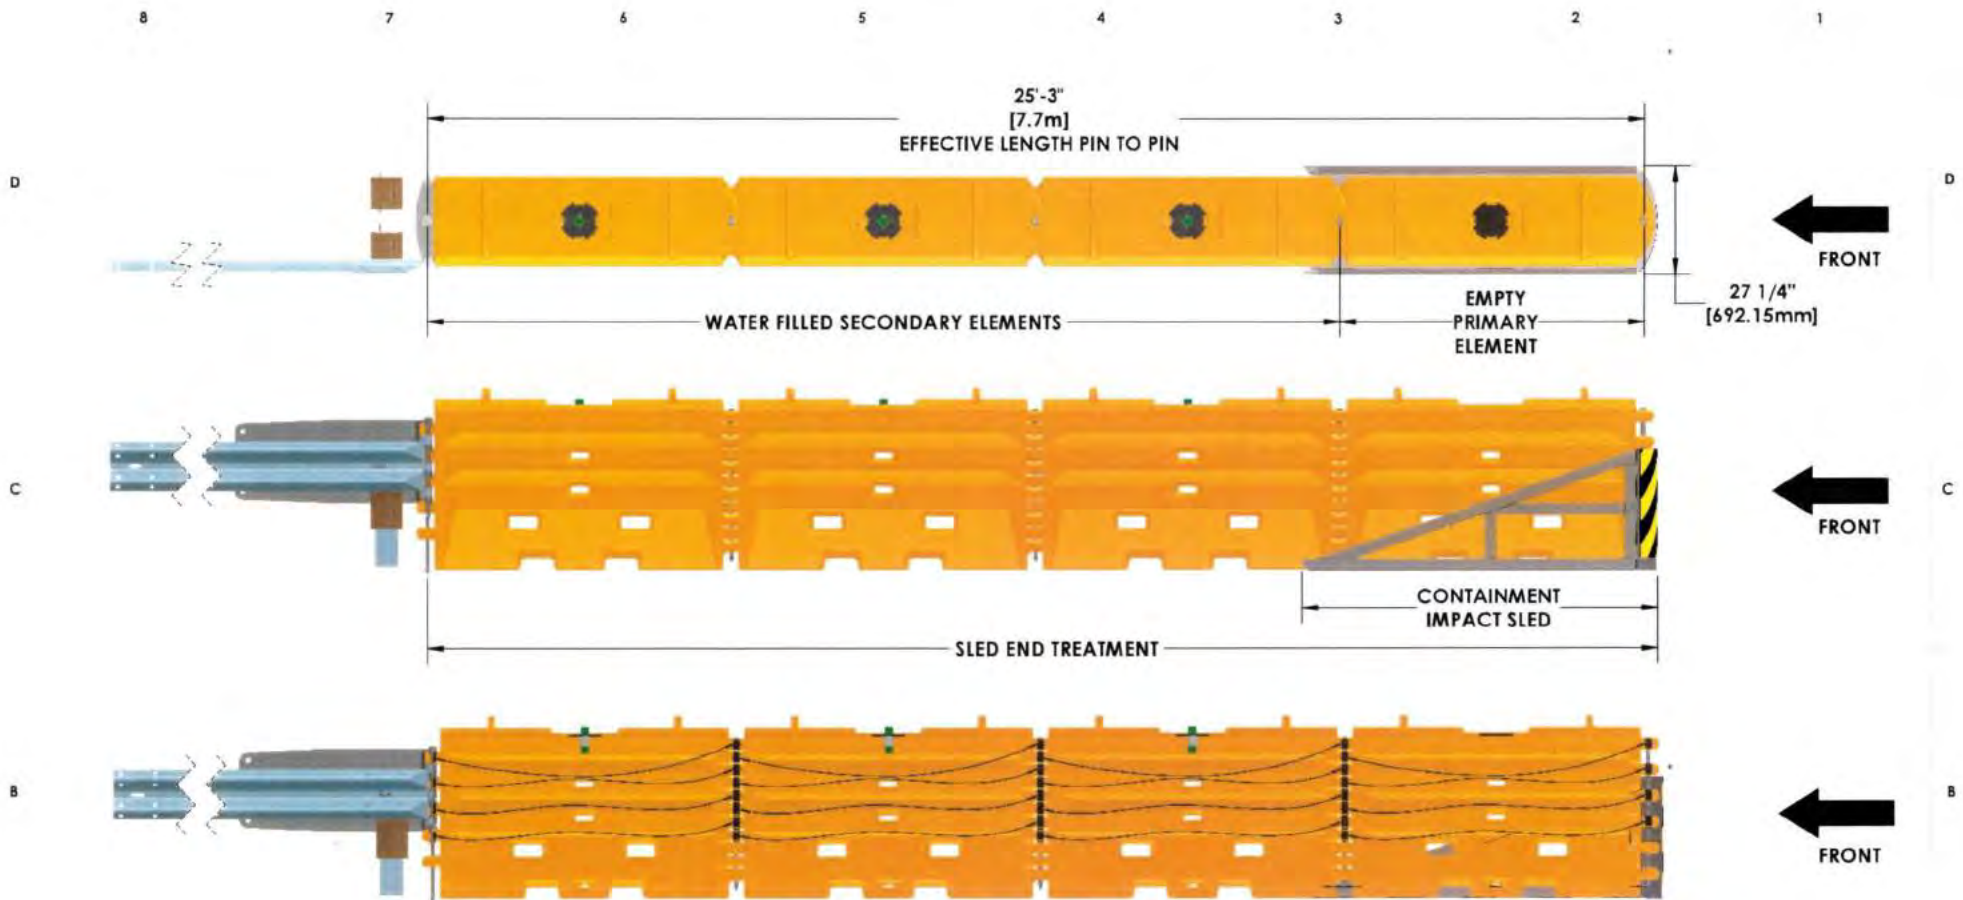
DWG. NO.
300-262

CUT AWAY SLED END TREATMENT
ALL SECTIONS CONTAIN INTERNAL MOLDED-IN CABLES

**SLED END
TREATMENT W/ GUARDRAIL**

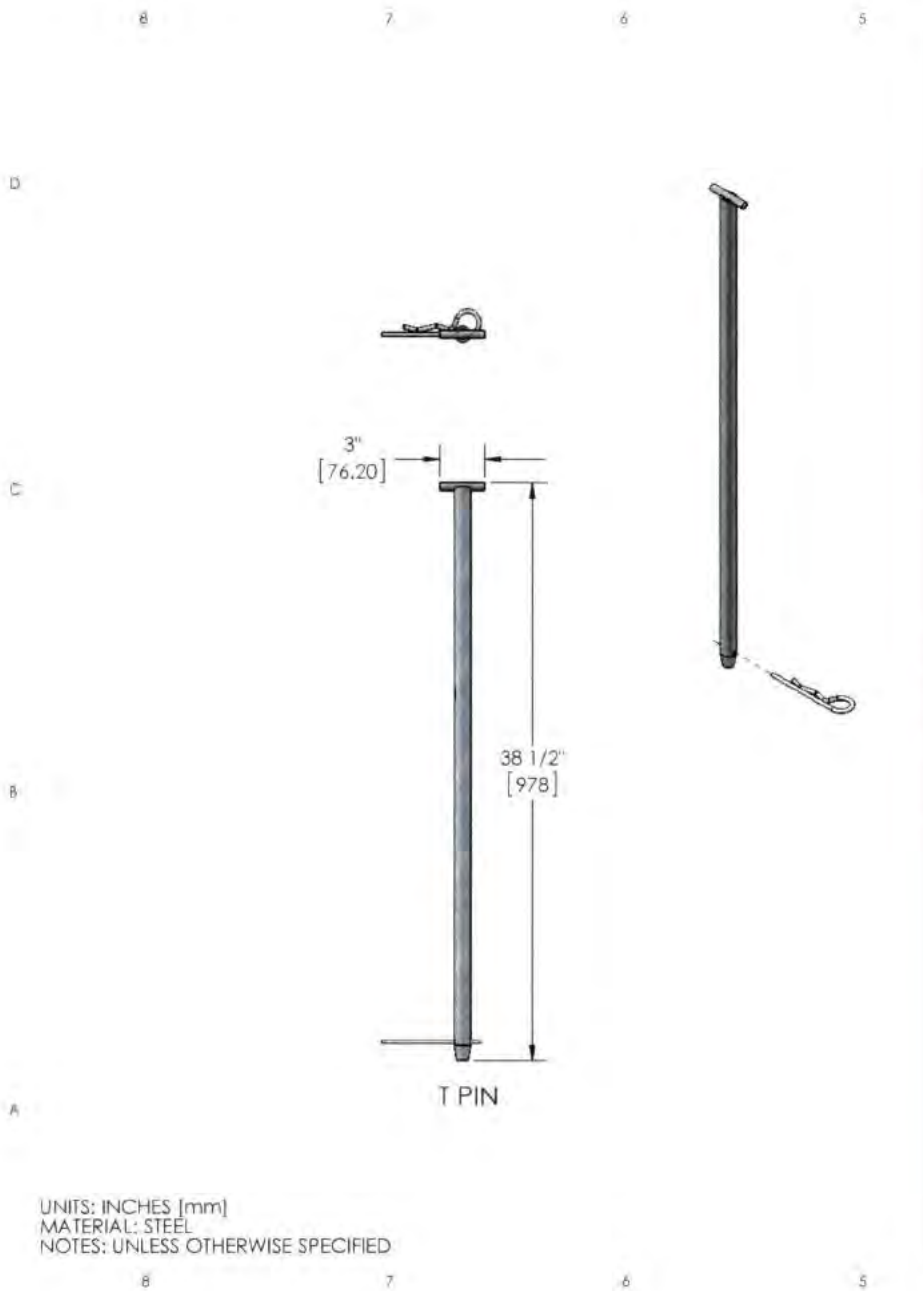
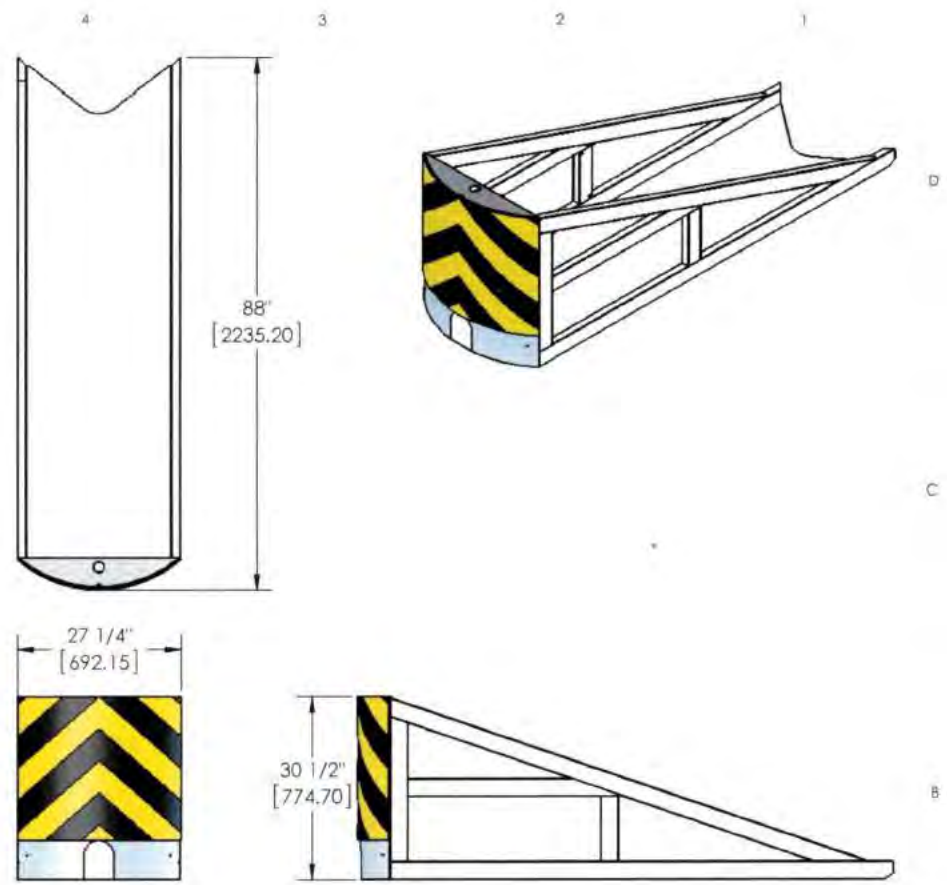
FRONT STEEL CAP

TITLE:
**SLED END TREATMENT
 HARDWARE**

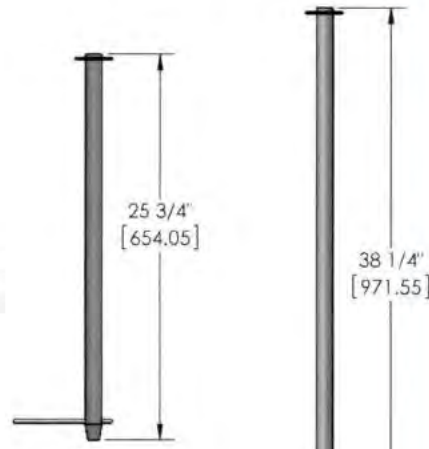
SHORT
OUTSIDE
TRANSITION PIN
W/ KEEPER PIN

LONG
CENTER
TRANSITION PIN
W/ KEEPER PIN

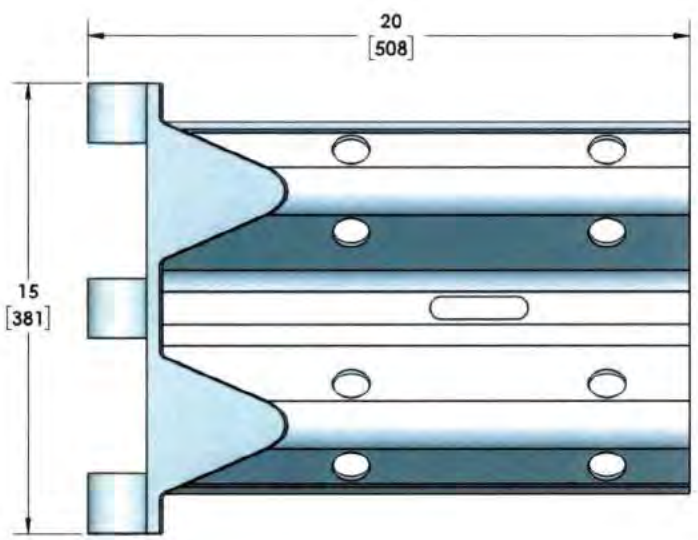
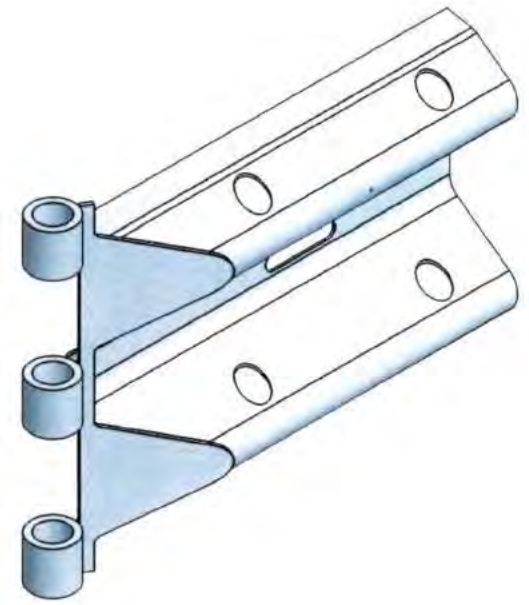
DWG. NO.
300-263

**W-Beam Guardrail
 Transition Panel**

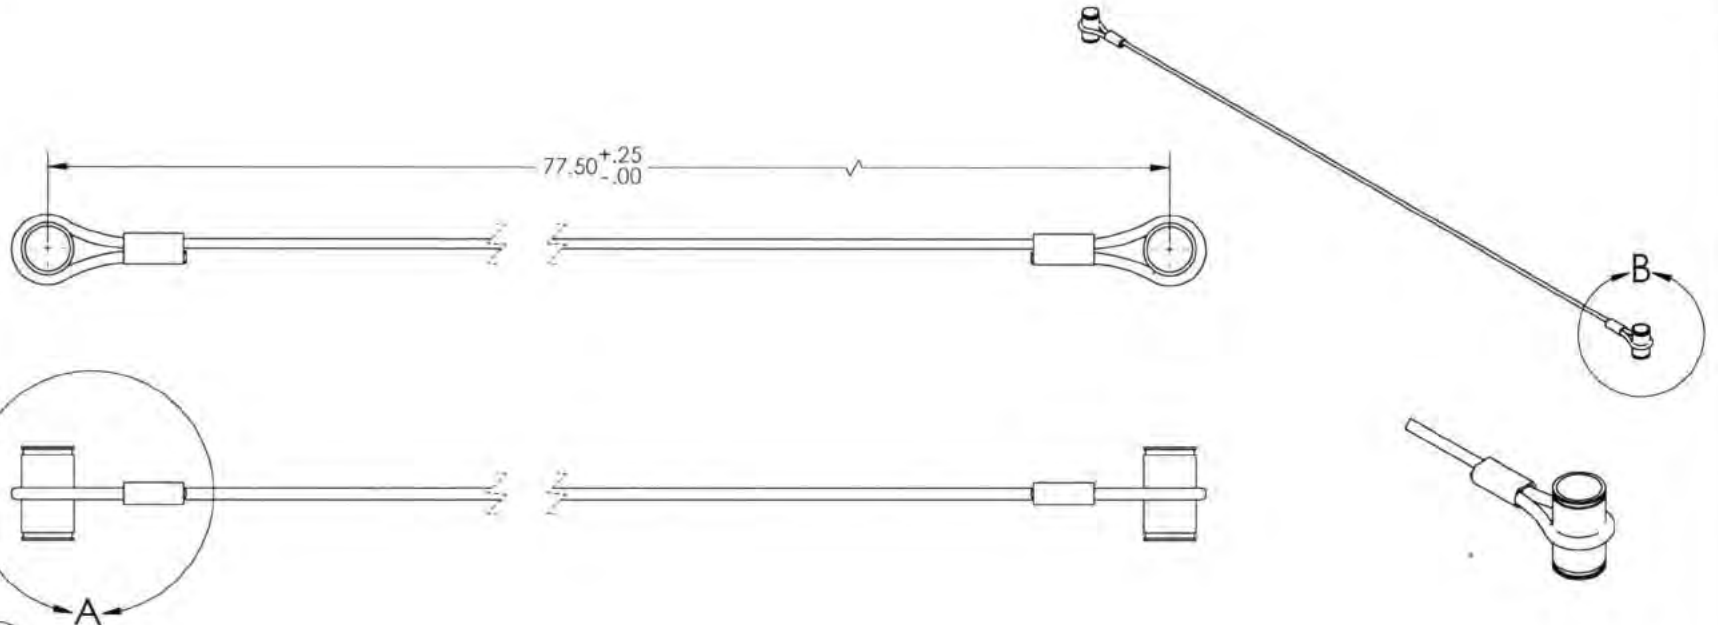
TITLE: **WATER WALL WIRE ROPE**

CABLE SPEC
 3/8" DIA WIRE ROPE
 CORROSION RESISTANT

ITEM NO.	DESCRIPTION	QTY
1	BUSHING	2
2	SWAGE	2
3	CABLE	1
