U.S. Department
of Transportation
**Federal Highway
Administration**

This letter is in response to your January 3, 2020 request for the Federal Highway Administration (FHWA) to review a roadside safety device, hardware, or system for eligibility for reimbursement under the Federal-aid highway program. This FHWA letter of eligibility is assigned FHWA control number CC-161 and is valid until a subsequent letter is issued by FHWA that expressly references this device.

Name of system: SLED Lo-Ro

Type of system: Crash cushion

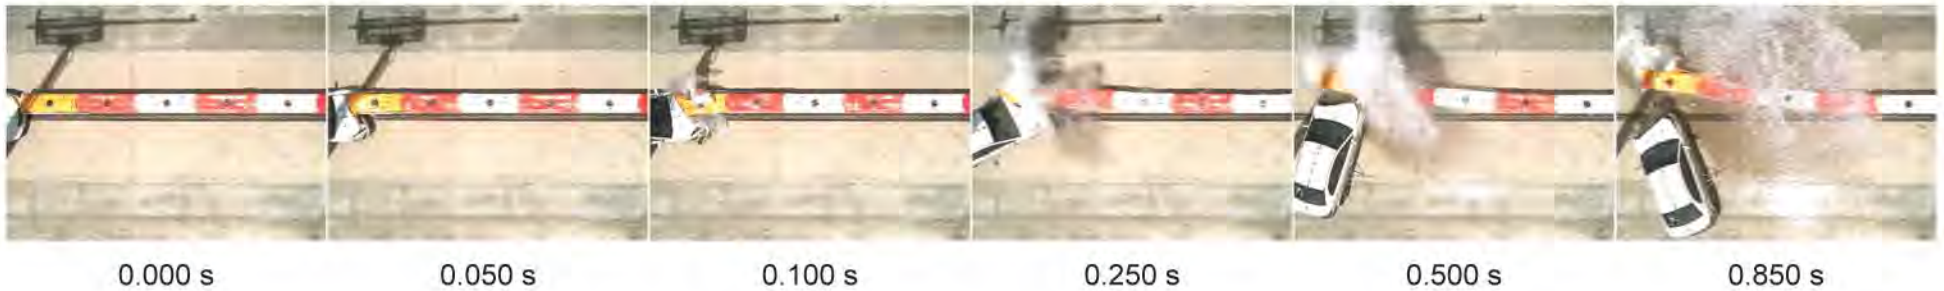
Figure 2 Summary of Test 2-40

MASH 2016 Test 2-40 Summary

General Information	
Test Agency.....	Applus IDIADA KARCO Eng.
Test No.....	P39135-01
Test Designation.....	2-40
Test Date.....	5/13/19
Test Article	
Name / Model.....	SLED Lo-Ro
Type.....	Crash Cushion
Crash Cushion Length.....	7.3 ft (2.2 m)
Installation Length.....	126.3 ft. (38.5 m)
Road Surface.....	Concrete
Test Vehicle	
Type / Designation.....	1100C
Year, Make, and Model.....	2007 Kia Rio
Curb Mass.....	2,330.2 lbs (1,057.0 kg)
Test Inertial Mass.....	2,439.4 lbs (1,106.5 kg)
Gross Static Mass.....	2,603.6 lbs (1,181.0 kg)

Impact Conditions	
Impact Velocity.....	44.34 mph (71.36 km/h)
Impact Angle.....	0.4° CCW
Location / Orientation.....	1.5 ft (457 mm) to the left
Kinetic Energy.....	160.3 kip-ft (217.4 kJ)
Exit Conditions	
Exit Velocity.....	N/A
Exit Angle.....	N/A
Final Vehicle Position.....	15.8 ft. (4.8 m) Downstream
	13.0 ft. (4 m) Right
Exit Box Criteria Met.....	N/A
Vehicle Snagging.....	Satisfactory
Vehicle Pocketing.....	None
Vehicle Stability.....	None
Maximum Roll Angle.....	-6.9°
Maximum Pitch Angle.....	-9.7°
Maximum Yaw Angle.....	115.5°

Occupant Risk	
Longitudinal OIV.....	35.1 ft/s (10.7 m/s)
Lateral OIV.....	4.3 ft/s (1.3 m/s)
Longitudinal RA.....	-6.4 g
Lateral RA.....	-1.7 g
THIV.....	35.4 ft/s (10.8 m/s)
PHD.....	6.4 g
ASI.....	1.33
Test Article Deflections	
Static.....	2.6 ft. (0.8 m)
Dynamic.....	4.2 ft. (1.3 m)
Working Width.....	4.8 ft. (1.5 m)
Debris Field.....	N/A
Vehicle Damage	
Vehicle Damage Scale.....	12-FL-4
CDC.....	12FLEW3
Maximum Intrusion.....	1.1 in. (27 mm) at wheel well / footwell

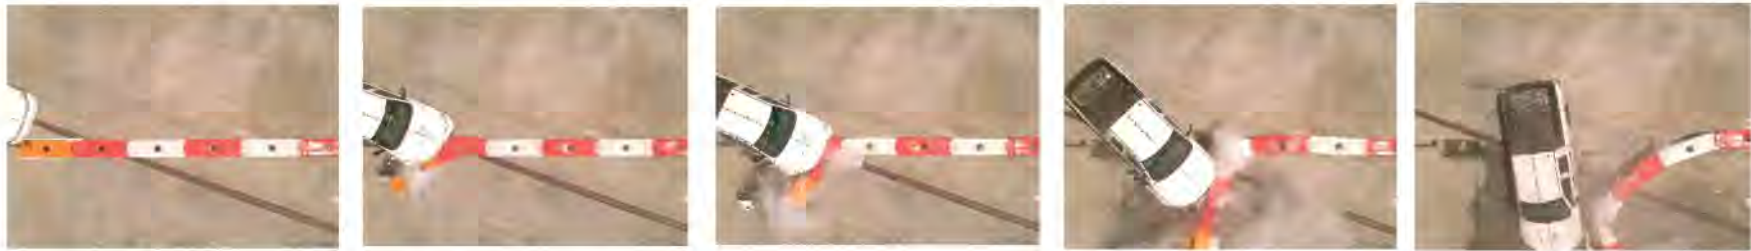
Figure 2 Summary of Test 2-44

MASH Test 2-44 Summary

General Information	
Test Agency.....	Applus IDIADA KARCO
Test No.....	P39203-01
Test Designation.....	2-44
Test Date.....	06/19/19
Test Article	
Name / Model.....	SLED Low Rotation (Lo-Ro)
Type.....	Crash Cushion
Crash Cushion Length.....	7.3 ft. (2.2 m)
Installation Length.....	126.3 ft. (38.5 m)
Road Surface.....	Concrete
Test Vehicle	
Type / Designation.....	2270P
Year, Make, and Model....	2014 RAM 1500
Curb Mass.....	5,062.8 lbs (2,296.5 kg)
Test Inertial Mass.....	4,951.5 lbs (2,246.0 kg)
Gross Static Mass.....	4,951.5 lbs (2,246.0 kg)

Impact Conditions	
Impact Velocity.....	42.25 mph (68.00 km/h)
Impact Angle.....	19.3°
Location / Orientation.....	1.9 in. (49 mm) Right
Kinetic Energy.....	295.5 kip-ft (400.6 kJ)
Exit Conditions	
Exit Velocity.....	N/A
Exit Angle.....	N/A
Final Vehicle Position.....	21.1 ft. (6.4 m) Downstream
	11.6 ft. (3.5 m) Right
Exit Box Criteria Met.....	N/A
Vehicle Pocketing.....	Satisfactory
Vehicle Stability.....	Satisfactory
Maximum Roll Angle.....	3.8 °
Maximum Pitch Angle.....	-12.6 °
Maximum Yaw Angle.....	-66.2 °

Occupant Risk	
Longitudinal OIV.....	23.6 ft/s (7.2 m/s)
Lateral OIV.....	3.3 ft/s (1.0 m/s)
Longitudinal RA.....	-4.1 g
Lateral RA.....	2.3 g
THIV.....	23.6 ft/s (7.2 m/s)
PHD.....	4.2 g
ASI.....	0.71
Test Article Deflections	
Static.....	42.6 ft. (13.0 m)
Dynamic.....	42.6 ft. (13.0 m)
Working Width.....	32.2 ft. (9.8 m)
Debris Field.....	35.1 ft. (10.7 m)
	14.9 ft. (4.5 m)
Vehicle Damage	
Vehicle Damage Scale.....	12-FR-6
CDC.....	12FDEW1
Maximum Intrusion.....	3.2 in. (80 mm) at Right Front Wheel Well

2-44 (2270P)	<p>Test report number P39203-01, conducted on 06/19/19. Test 2-44 involves an 2270P test vehicle impacting the system at a nominal speed and angle of 44 mph (70 km/h) and 20° with the centerline of the vehicle directed to the leading corner of the first Lo-Ro module. This angle and barrier intersection directed the test vehicle into the front of the steel Containment Impact SLED (CIS) at its CIP as defined in MASH for non-redirective crash cushions. The side angled impact examines the risk of vehicle instability and occupant compartment deformation. The test vehicle was a commercially available 2014 RAM 1500 with a test inertial mass of 4,951.5 lbs (2,246.0 kg).</p> <p>The vehicle impacted the system at a speed and angle of 42.25 mph (68.00 km/h) and 19.3°, respectively. Upon impact the vehicle pushed the SLED and adjacent Lo-Ro modules to the non-traffic side. The Primary module and the first Lo-Ro modules were ruptured and released water. The vehicle remained upright and was brought to a controlled stop. The vehicle came to rest 21.1 ft. (6.4 m) downstream from its first point of contact with the CIS. The SLED and Lo-Ro modules remained tethered together via the steel t-pin between module knuckles which connects directly to the internal molded in steel cables. There were no detached elements that showed potential to penetrate the vehicle or present undue hazards to personnel in a work zone. The Occupant Impact Velocities (OIV) and Ridedown accelerations were within the specified limits of MASH. The roll and pitch angles did not exceed 75° and there was minimal occupant compartment deformation. The SLED Lo-Ro met all the requirements for MASH Test 2-44.</p>	PASS

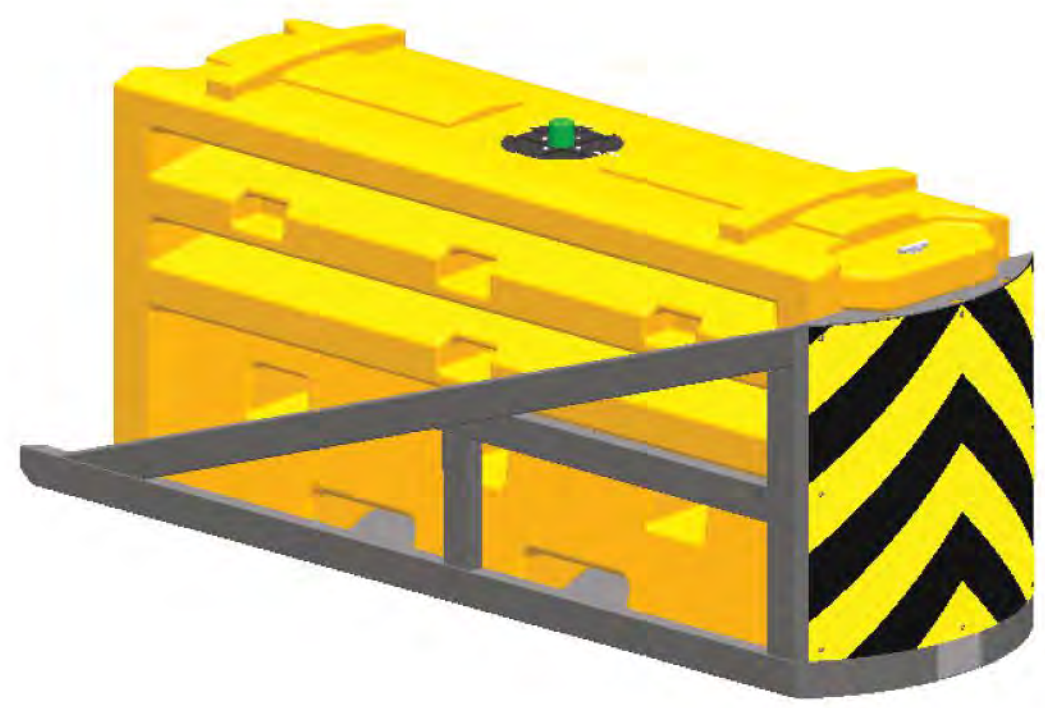
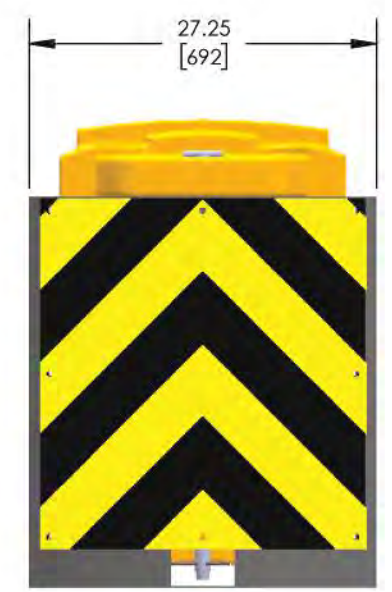
SIZE **B** DWG. NO. **300-327** REV **A**

ITEM NO.	DESCRIPTION
1	8" Dia. Fill Hole w/ Twist Lock Lid
2	Connection T-Pin
3	SLED Low Rotation CIS Frame
4	SLED Low Rotation Module

TITLE:
SLED Low Rotation Primary Module

The modules are 6.3 ft. (1.9 m) long measured from pin to pin by 22.5 in. (572 mm) wide by 36.0 in. (914 mm) tall. The modules were manufactured from polyethylene that is UV stabilized to minimize degradation. The system has one (1) water filled front module pinned to the steel CIS. The empty module weighs approximately 159.0 lbs (72.2 kg) and the water filled modules weigh approximately 1,633 lbs. (740.8 kg).

Molded within the plastic modules are a series of three (3) corrosion resistant wire rope cables. The cables are permanently molded into the modules during the manufacturing process. The modules are designed with knuckles at the ends which contain a series of vertically aligned concentric holes that allow a steel t-pin to be inserted to connect adjacent modules. When adjacent modules are pinned together there are a total of nine (9) knuckles aligned with the steel t-pin inserted. This provides a positive connection between adjacent modules.

Each water filled module contains a fill lid which incorporates a water level indicator. The water level indicator pop up float is a visual indicator for identifying that the modules are filled to the appropriate water level.
